PROJECT INSPECTION REPORT

PROJECT NAME: Crescent Wastewater Treatment Facility

DATE AND TIME: 2/14/19 11:30 AM

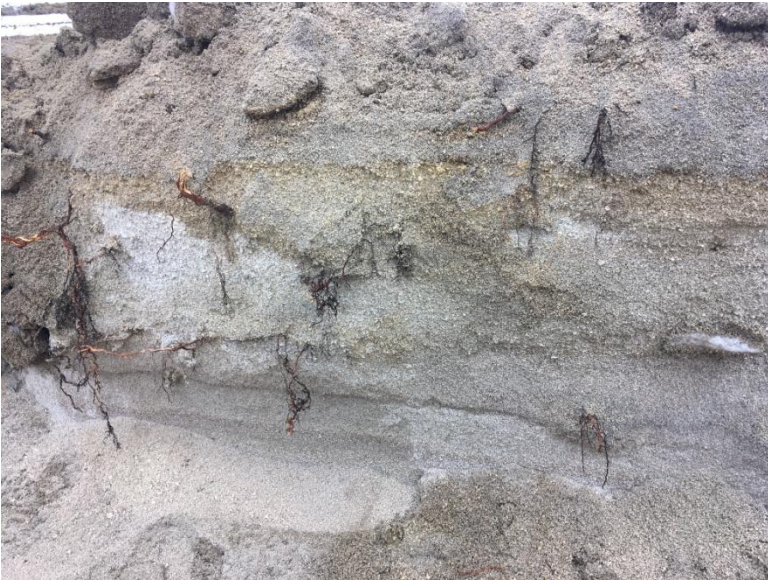
Figure 1: Exposed cut of the native stratigraphy. Note the predominance of pumice sands and gravels and paucity of fine-grained materials.

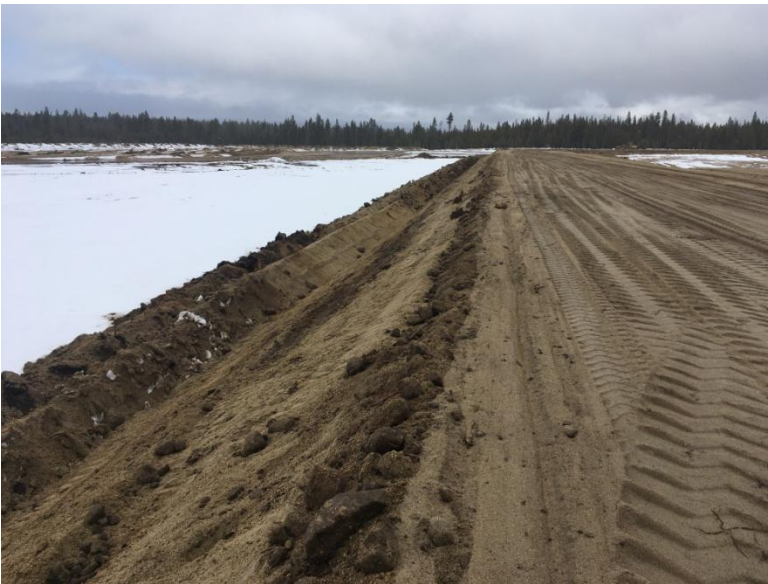
Figure 2: Looking north at the berm between the western lagoon and the storage pond. This area has been compacted to over 90%. Note the tire marks and slump forming at the sides of the berm.

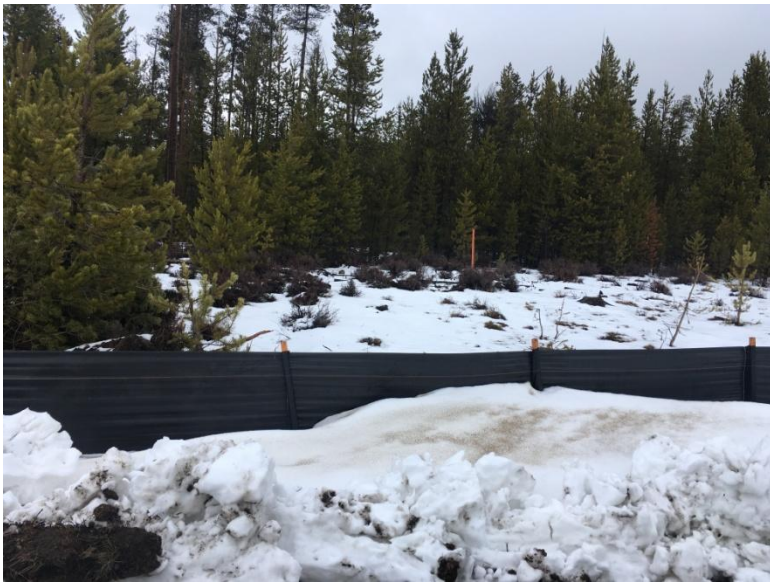
Figure 3: Looking north at the silt fence. Silt fence is approximately 47' south of the property boundary.

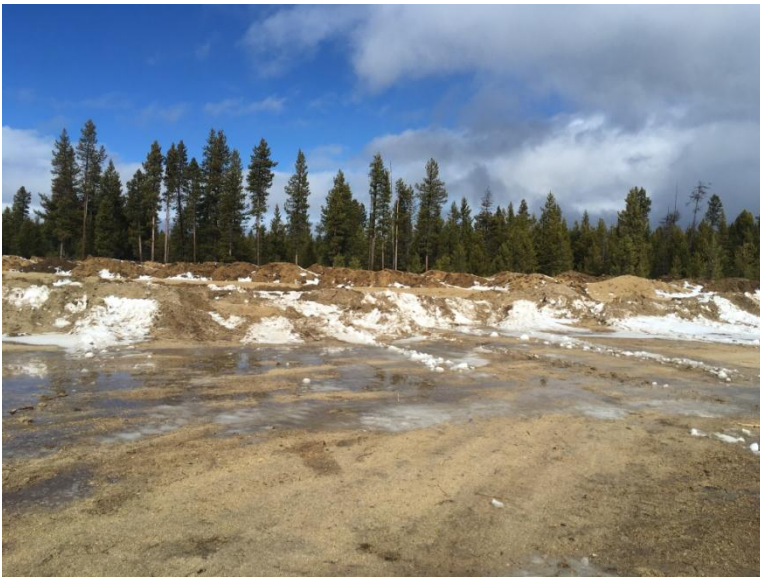
Figure 4: Looking northwest at the storage pond. Note the staging of build up materials. The “darker” piles consist of a lithology more amenable to supporting the berms.

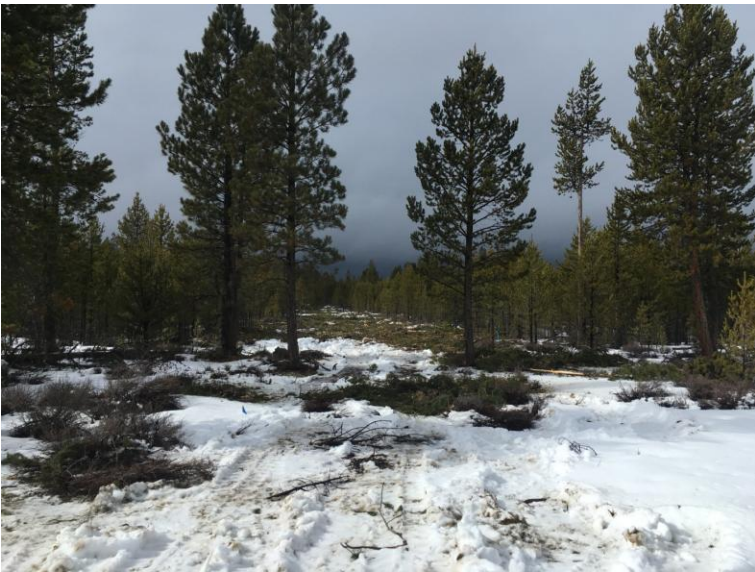
Figure 5: Looking west at the grubbed irrigation main line.

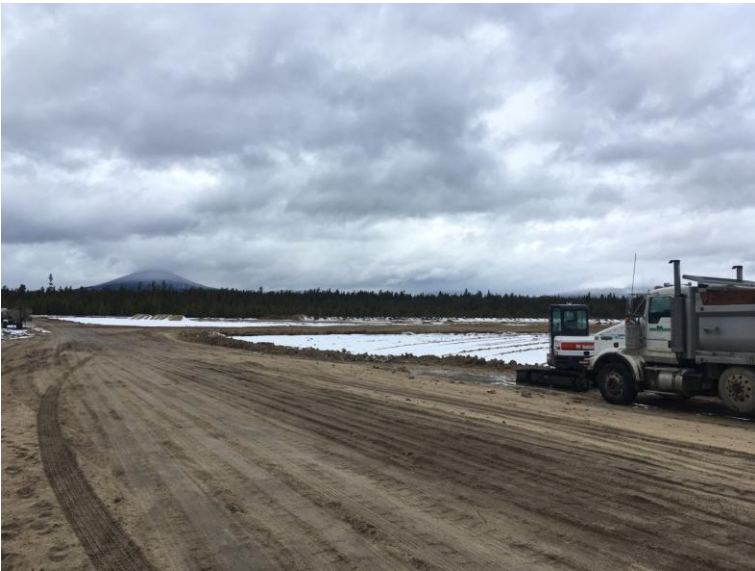
Figure 6: Looking west at the corner of the western lagoon, with the separation berm and storage pond in the background.
