### **PROJECT INSPECTION REPORT**

**PROJECT NAME:** Crescent Wastewater Treatment Facility

**DATE AND TIME:** 3/29/19 1:00 PM

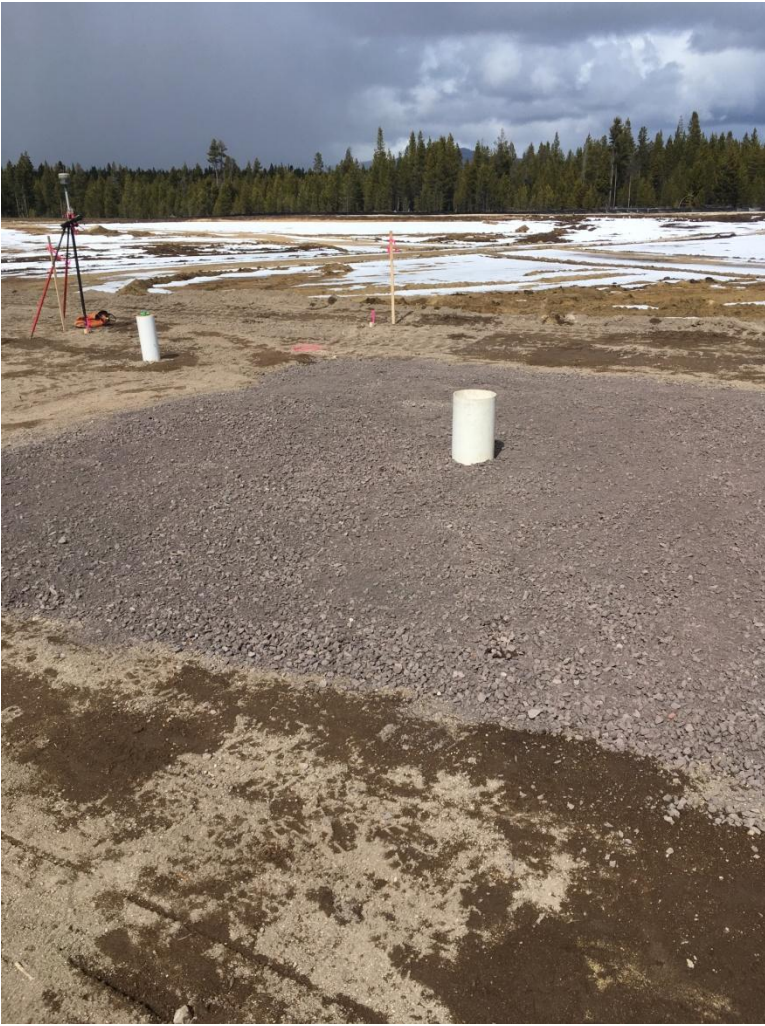
Figure 1: Looking north at the rocky pad where the chlorination building will sit. Notice the two pipe opening set up and awaiting connection to the system.

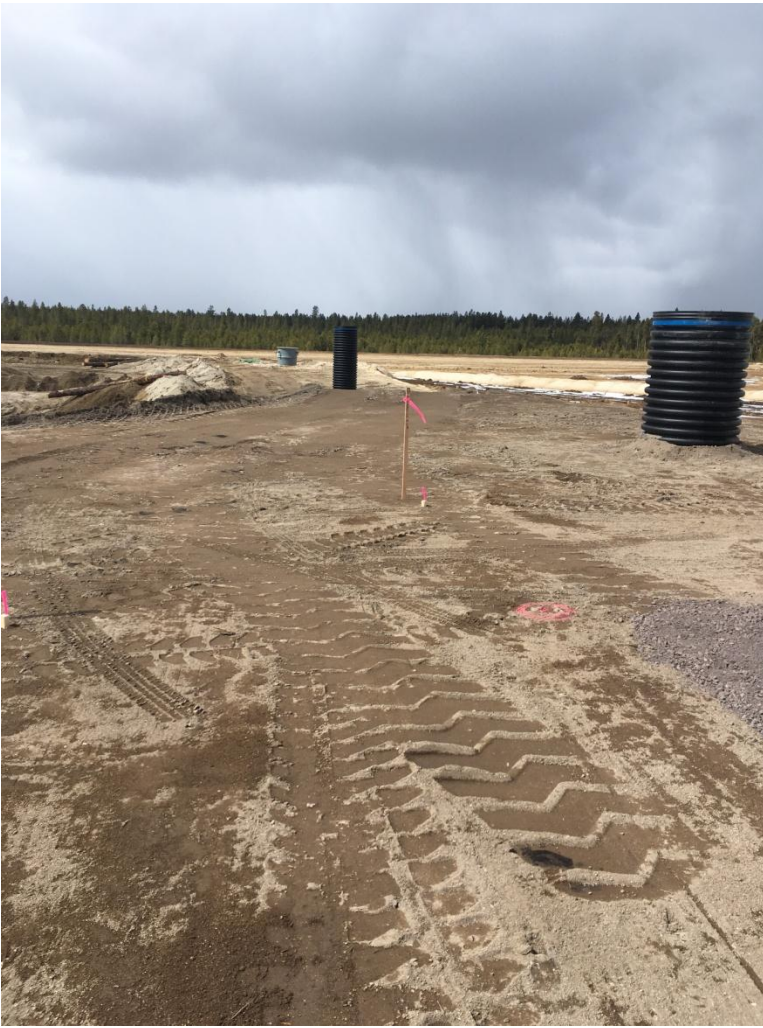
Figure 2: Looking west at the new soil blend used to build up the berm. Note the lack of tire treads. Note the risers in the background and the lift station in the far back center of the picture.

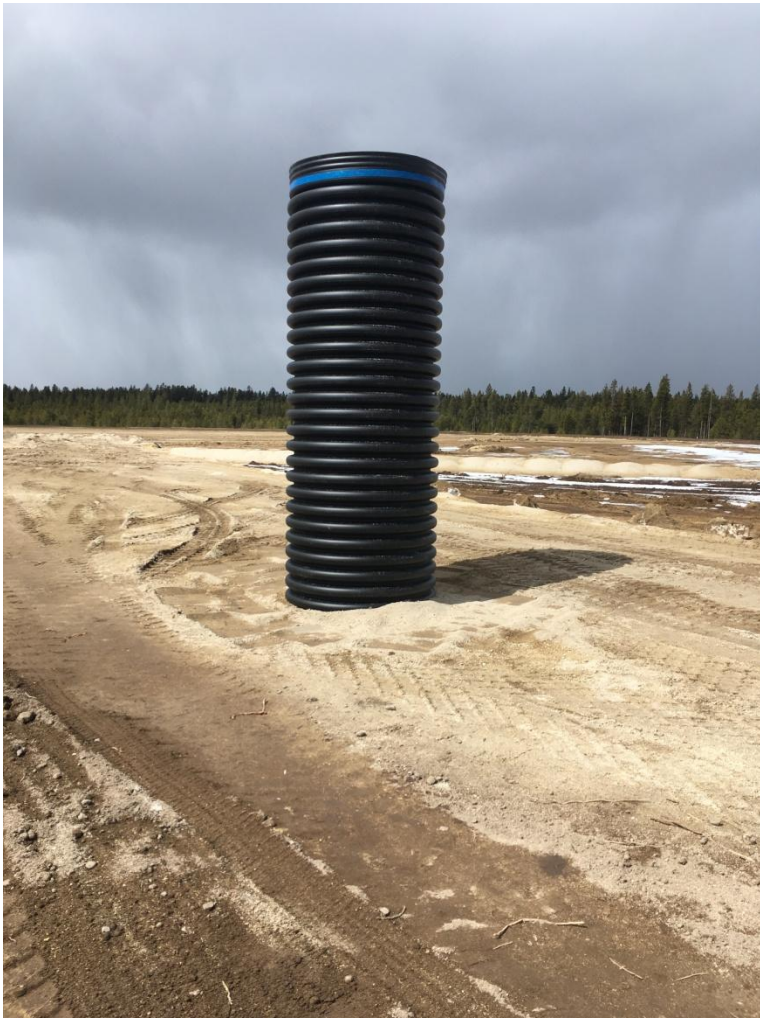
Figure 3: Looking northwest at one of the risers seated on the chlorinator.

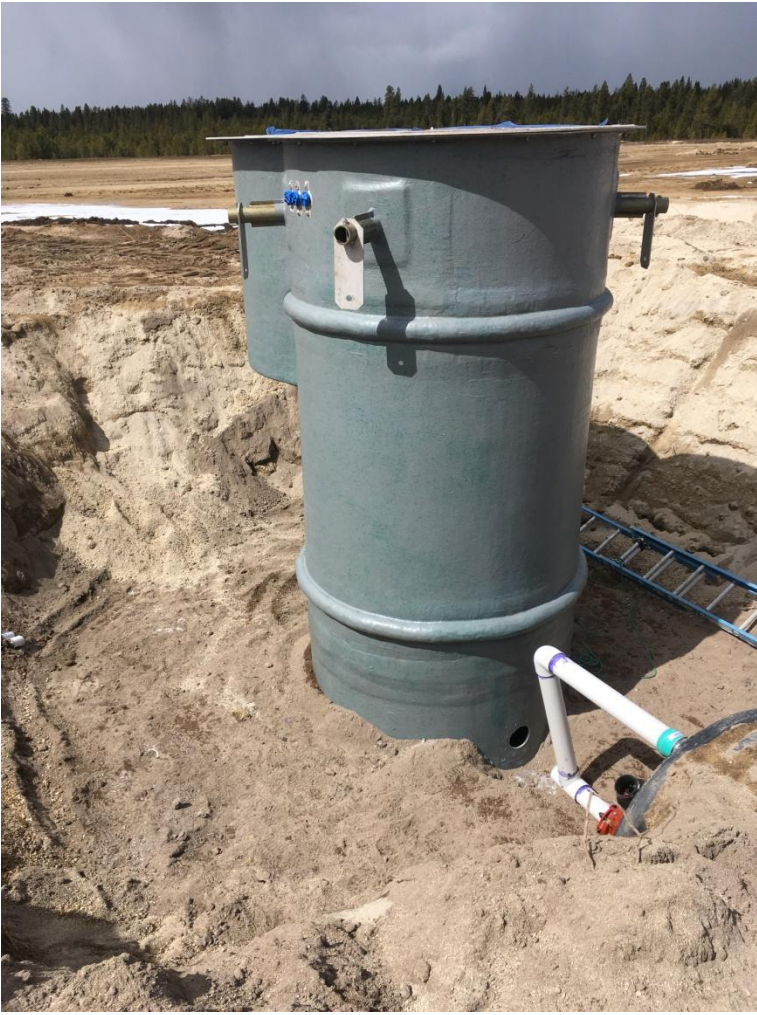
Figure 4: Looking northwest at the installed lift station.

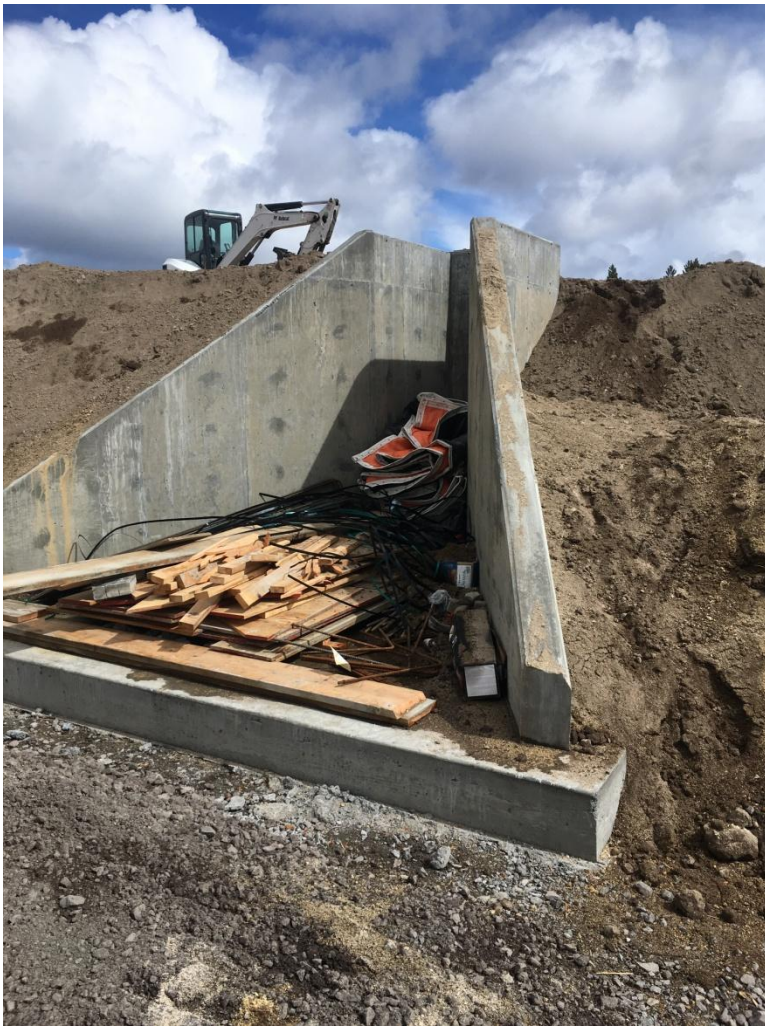
Figure 5: Looking east at the slab and walls recently poured for the crossflow structure.

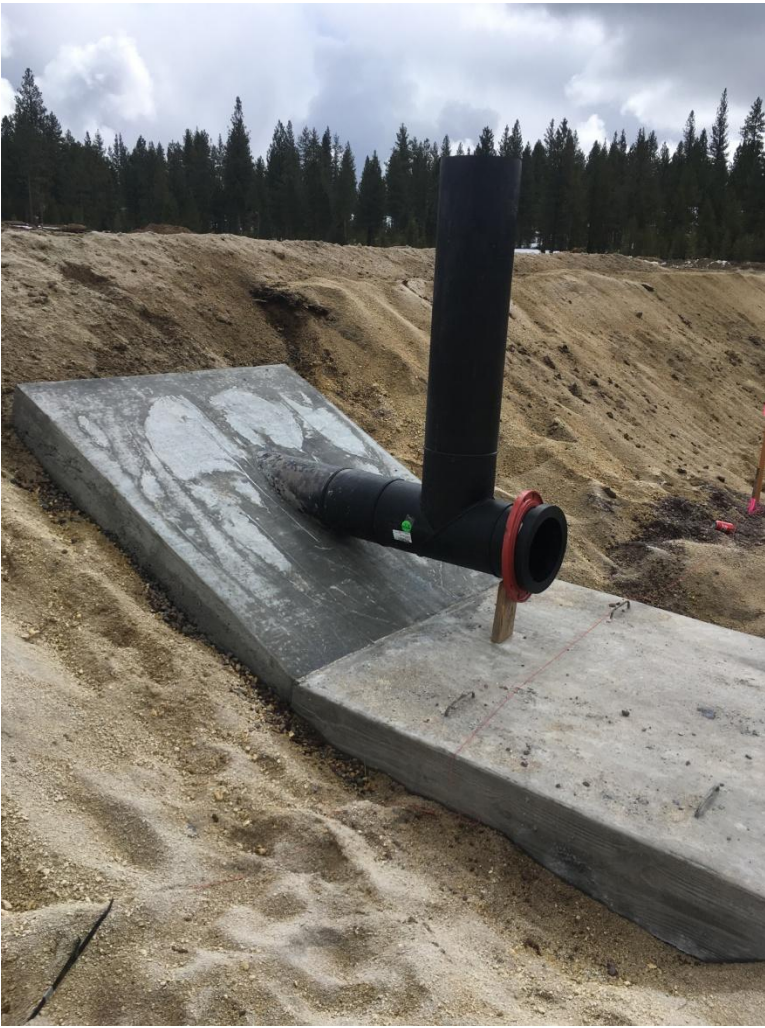
Figure 6: Communication crossflow structure rat wall (western).

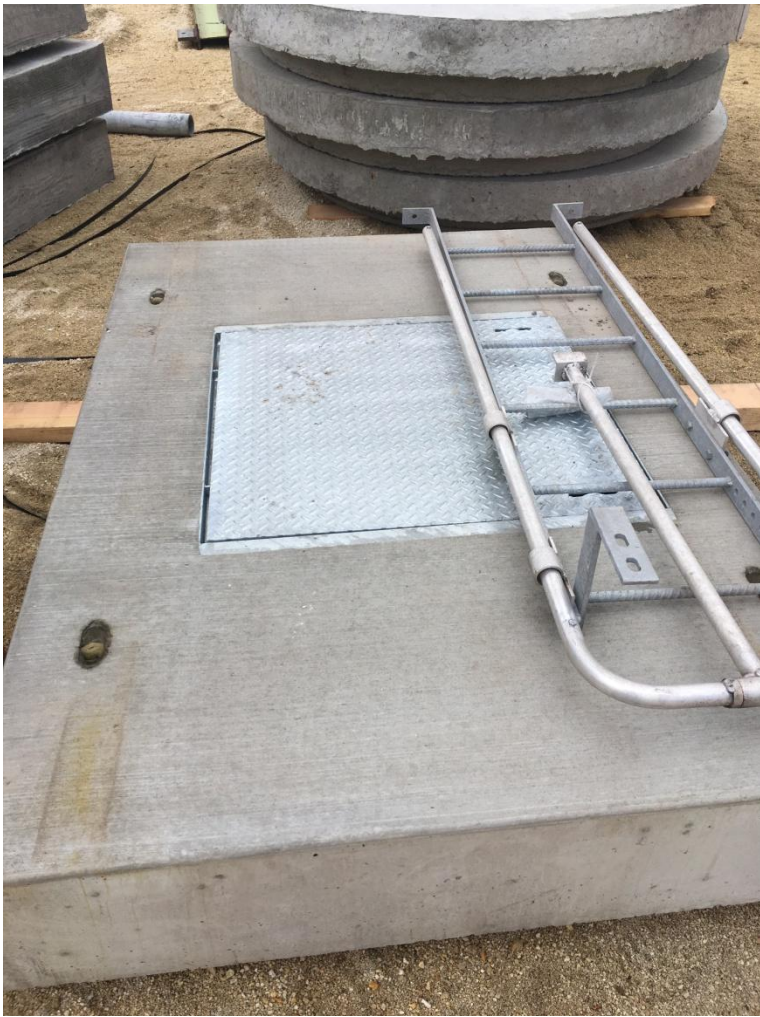
Figure 7: Materials on site.

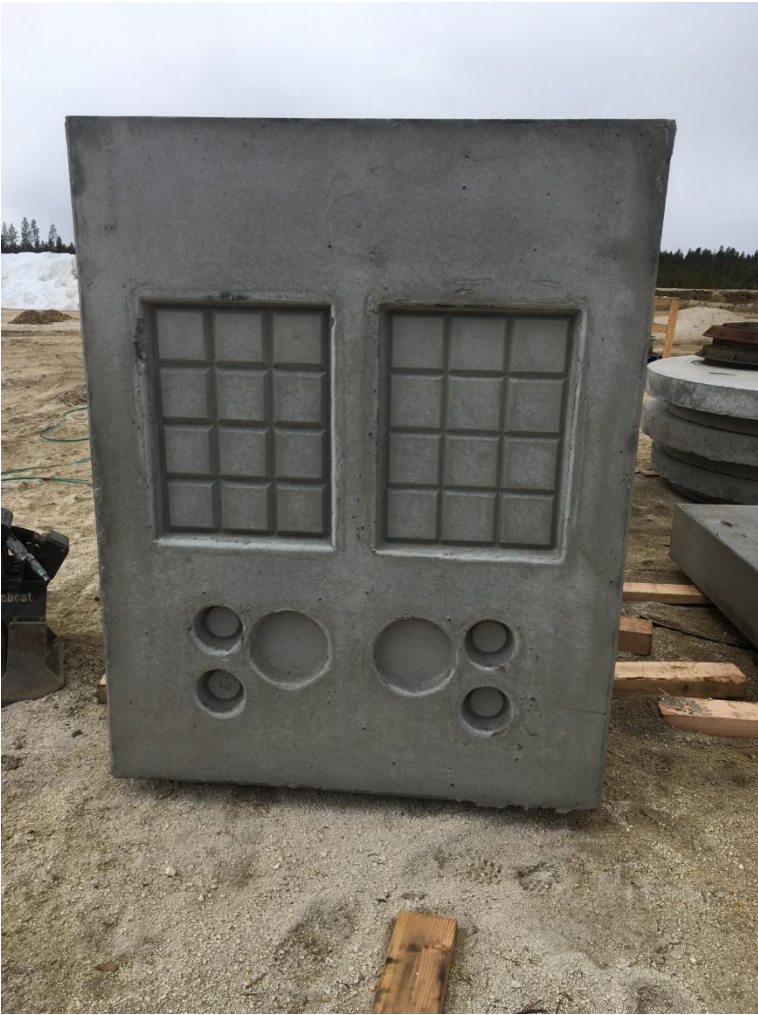
Figure 8: Materials on site.
