PROJECT INSPECTION REPORT

PROJECT NAME: Crescent Wastewater Treatment Facility

DATE AND TIME: 4/24/19 10:00 AM

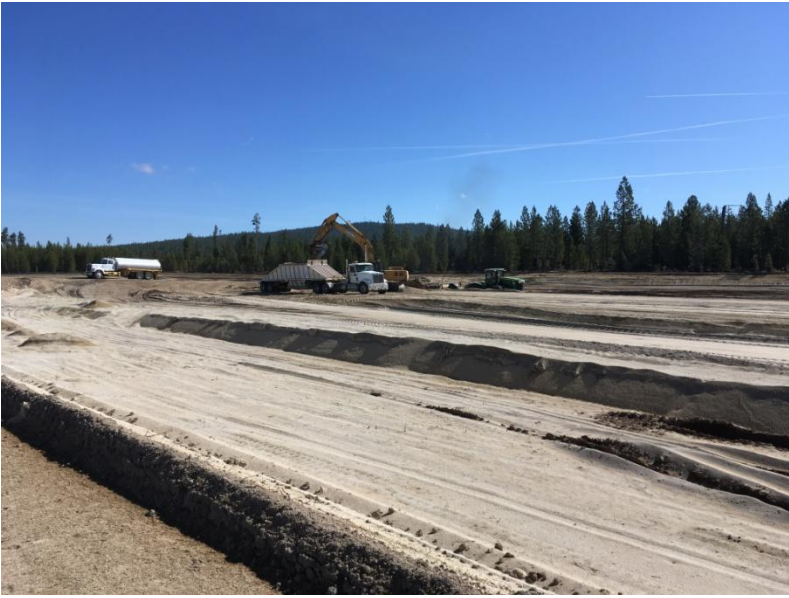
Figure 1: Looking northeast at the excavator moving materials into the belly dump for discing operations.

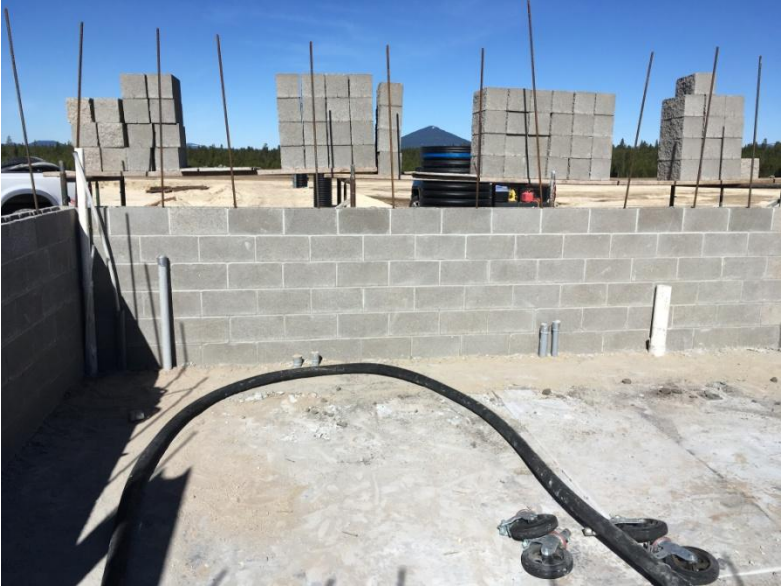
Figure 2: Looking west at the interior of the chlorinator building. Note the pipes and conduits awaiting connection.

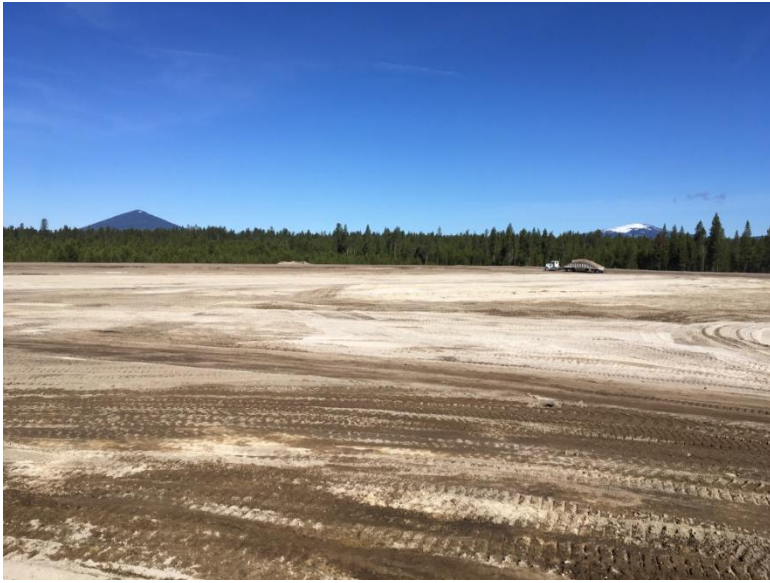
Figure 3: Looking northwest at the nearly completed storage pond. Note the belly dump in the background delivering dirt for discing operations.

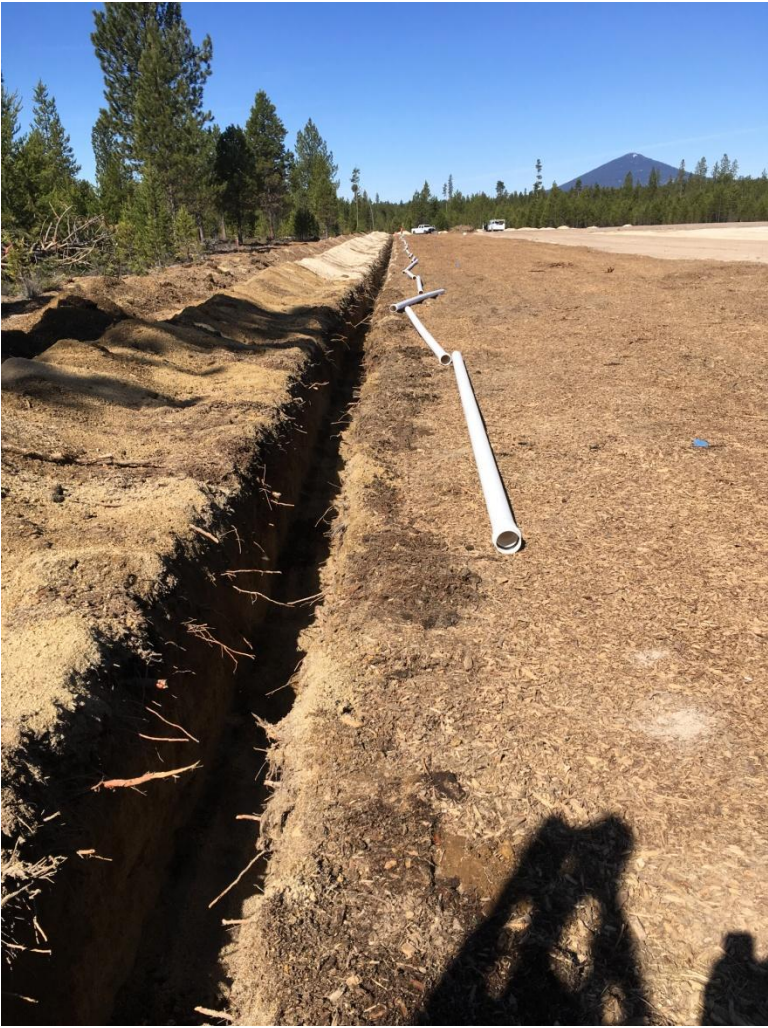
Figure 4: Looking west at the trench that they will lay the sewer line in.

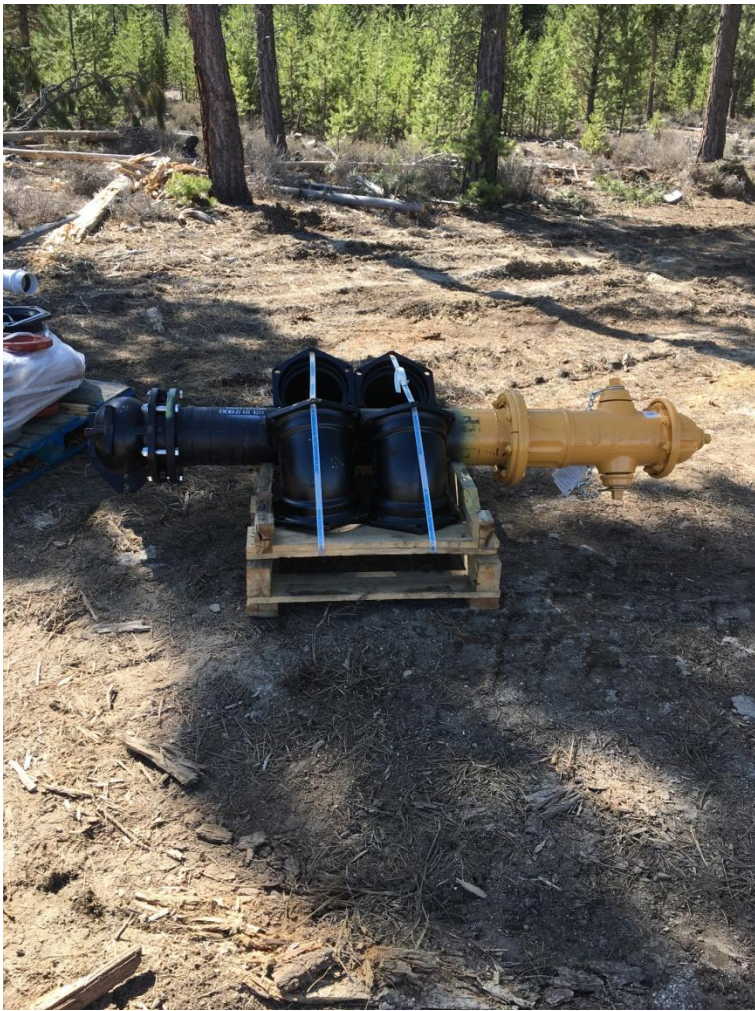
Figure 5: Materials on site – the fire hydrant.

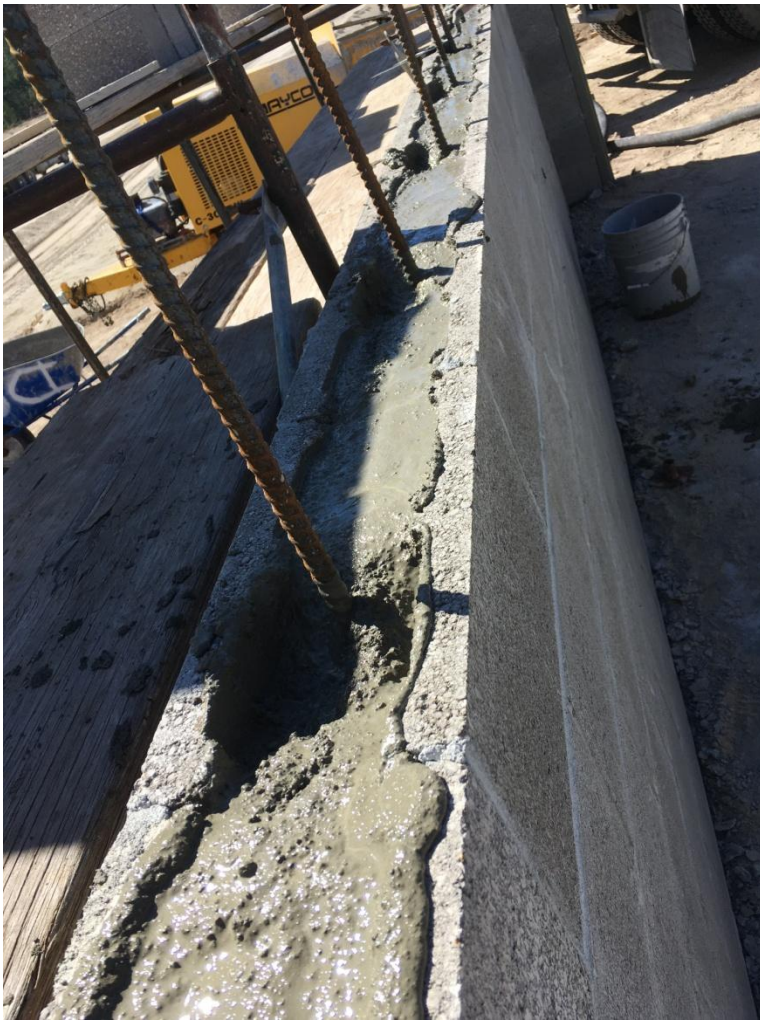
Figure 6: Concrete operations to fill in the chlorination building walls. Note that the rebar was position to stand vertically and in the center of the precast concrete blocks.
