### **PROJECT INSPECTION REPORT**

**PROJECT NAME:** Crescent Wastewater Treatment Facility

**DATE AND TIME:** 6/12/19 10:00 AM

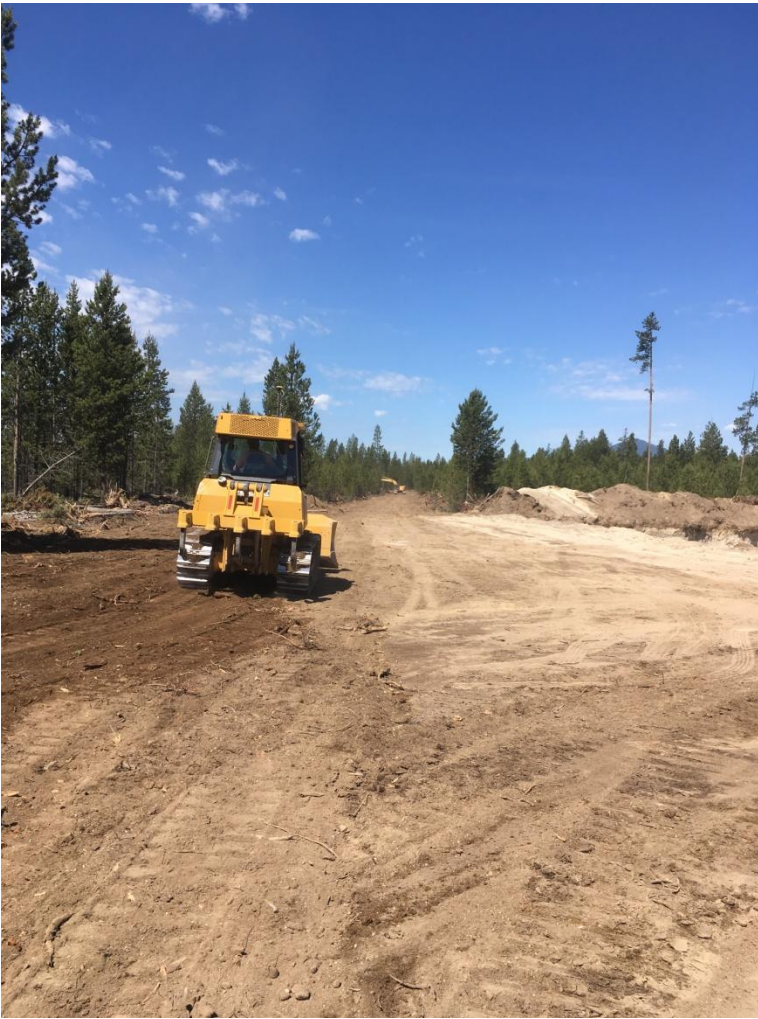
Figure 1: Looking west at the irrigation main line being cleared in order to lay pipe and eventually create an access road.

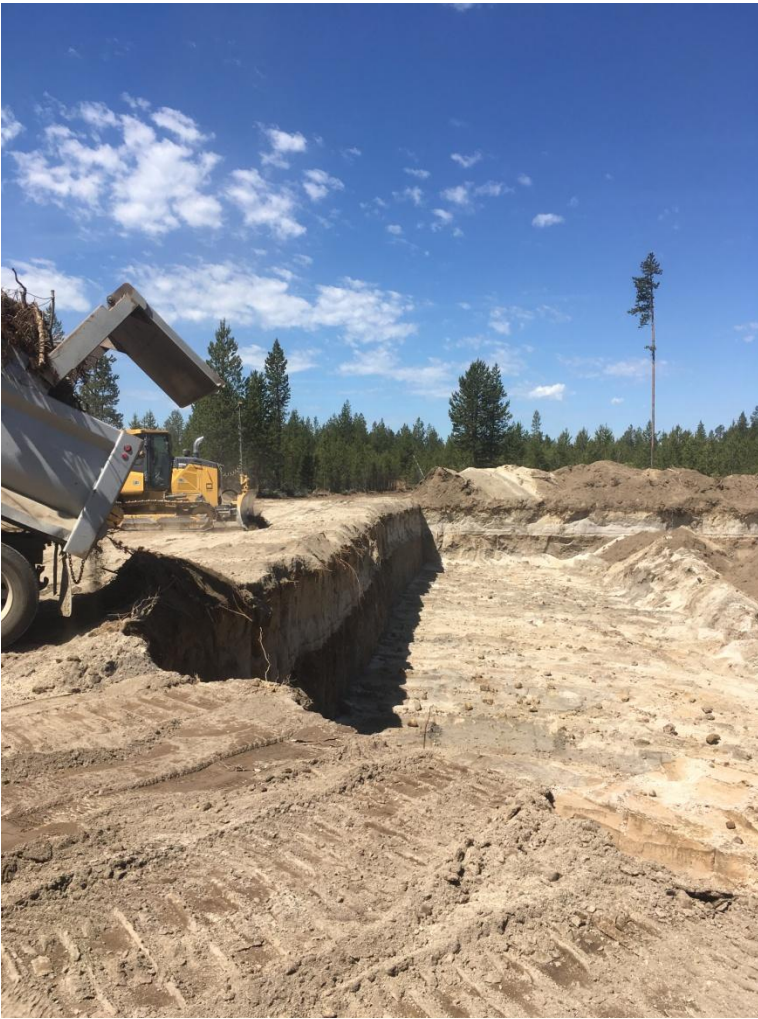
Figure 2: Looking west at a large trench dug to place displaced tree and root materials that are not needed while clearing the irrigation main line access road.

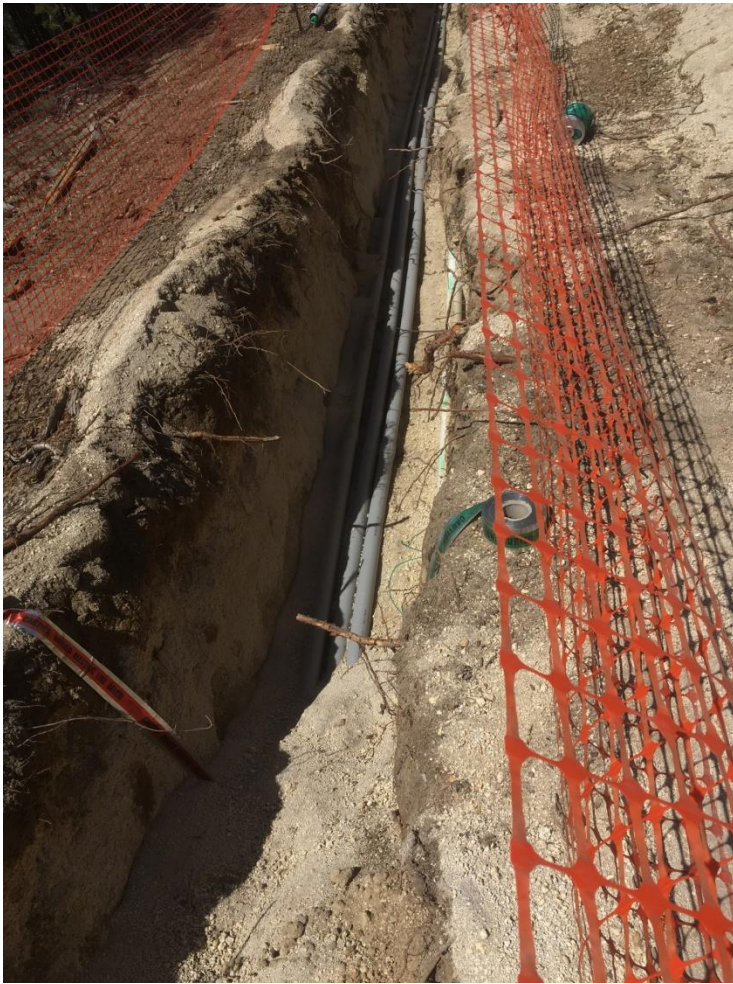
Figure 3: Looking west at the electrical conduits in place and awaiting connection to the grid after the gasoline crossing is completed.

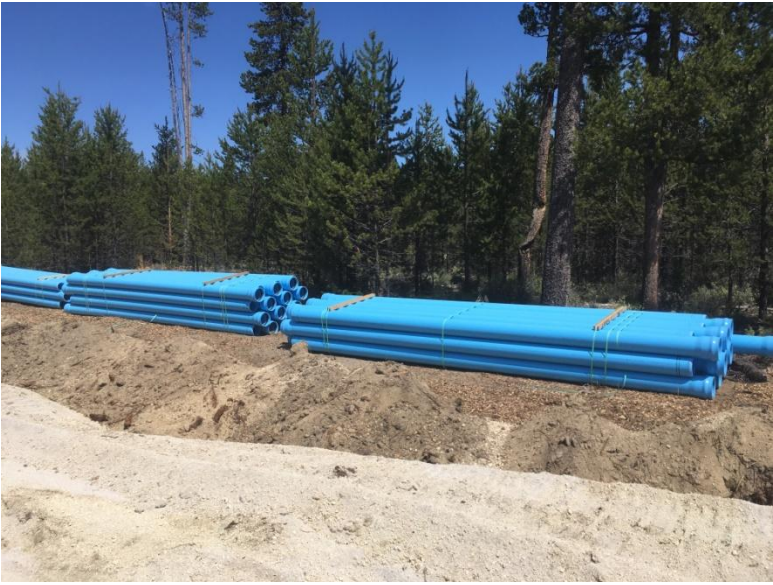
Figure 4: Water line pipes are on hand and awaiting installation.

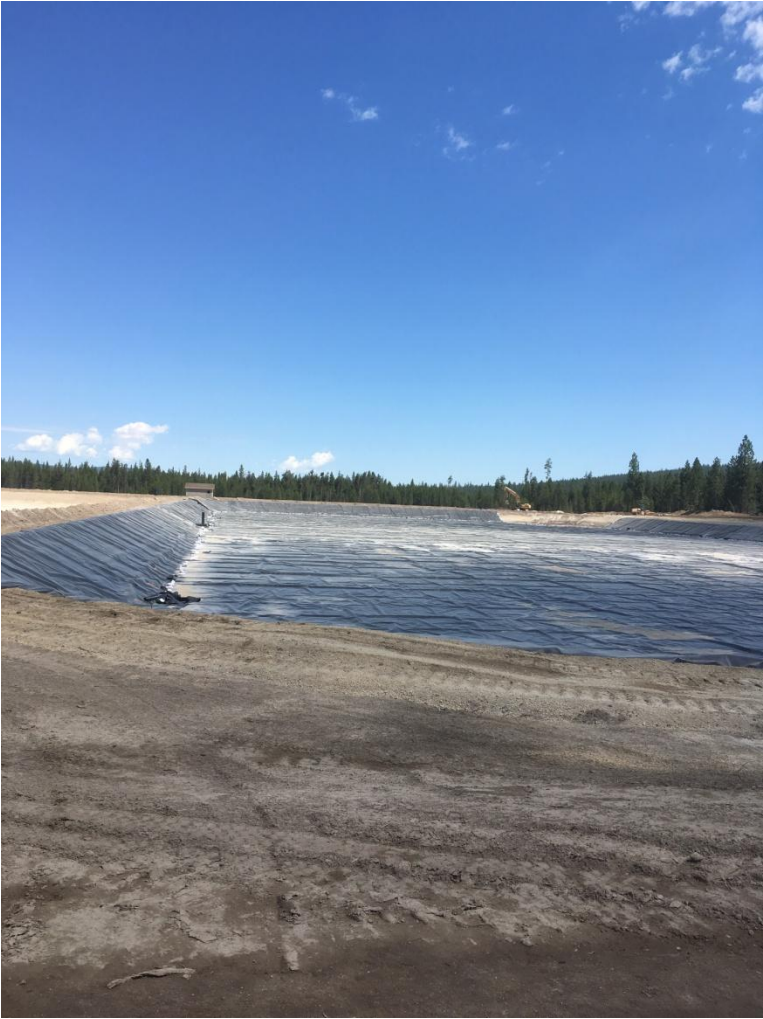
Figure 5: Looking north at the lined eastern lagoon.

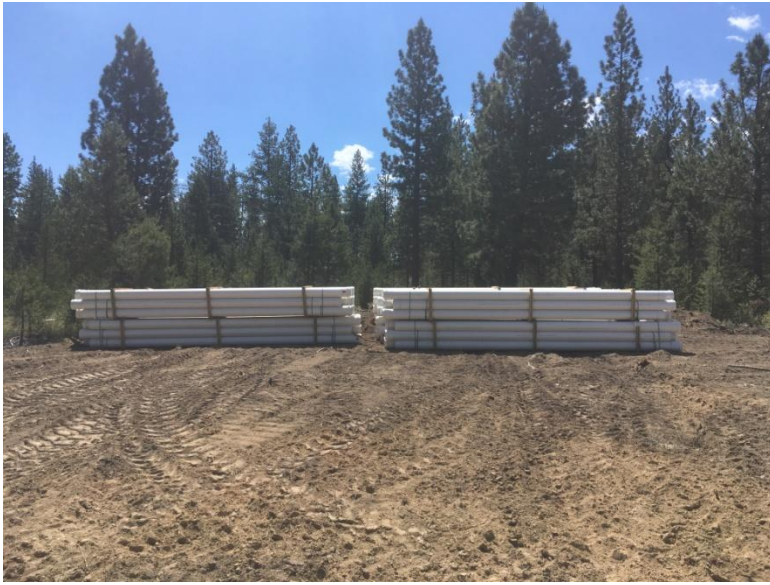
Figure 6: Irrigation lines on hand and awaiting installation. These white pipes will be marked by a purple strip to specific non-potable, reclaimed water, as per DEQ regulations.
