PROJECT INSPECTION REPORT

PROJECT NAME: Crescent Wastewater Treatment Facility

DATE AND TIME: 6/5/19 9:00 AM

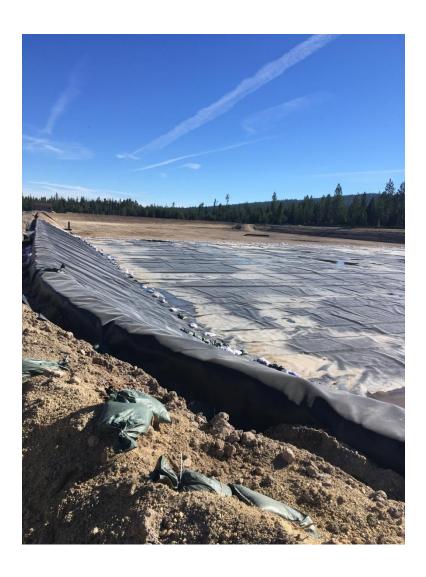
Figure 1: Looking north at the eastern lagoon and the progress of liner installation. Note the sand bags throughout the liner necessary to secure it in place.

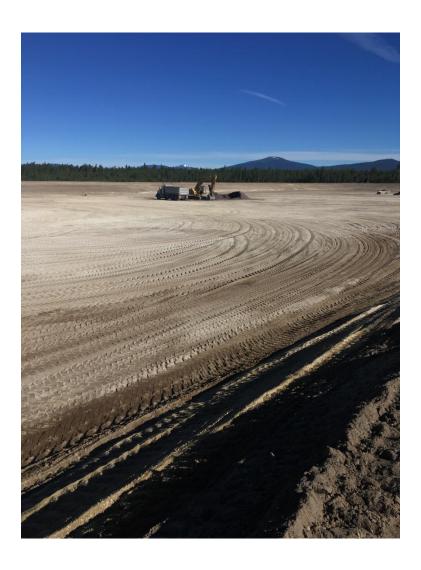
Figure 2: Looking north at the western lagoon. Note the lagoon is to grade, minus the small amount of staging materials that will be removed before liner operations begins in this lagoon.

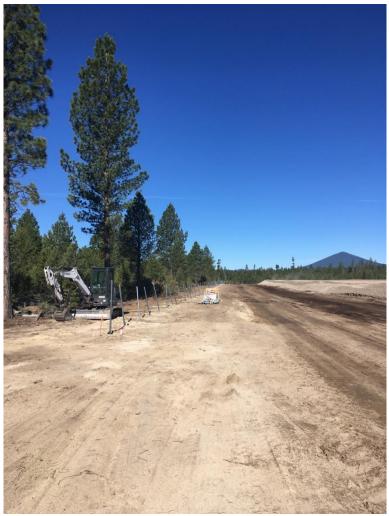
Figure 3: Looking west at the placement of fence poles for the cyclone fence that will run the perimeter of the facility.

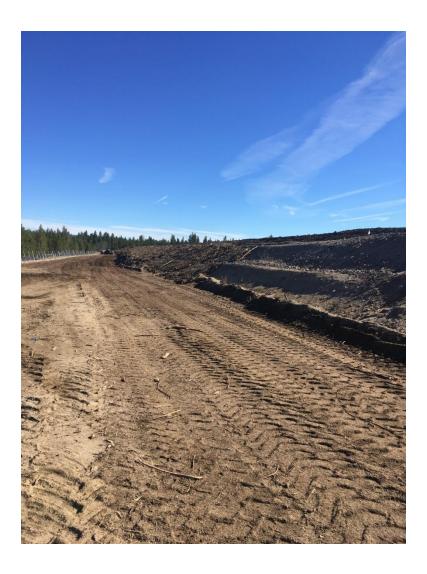
Figure 4: Looking north at the western-most berm along the storage pond. Note that amouring has been completed on the northern slope, to about half way through the picture with material stacked and waiting for amouring to be complete.

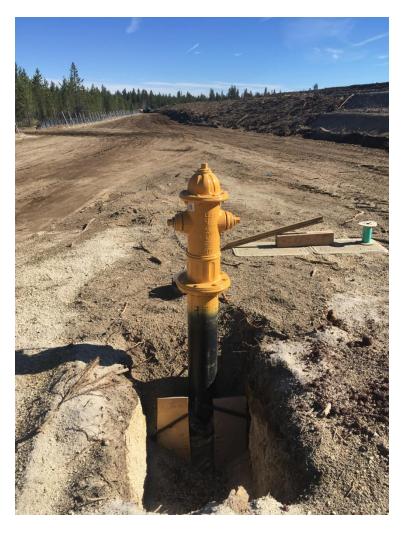
Figure 5: The installed fire hydrant to be used for dust suppression by the fire service.

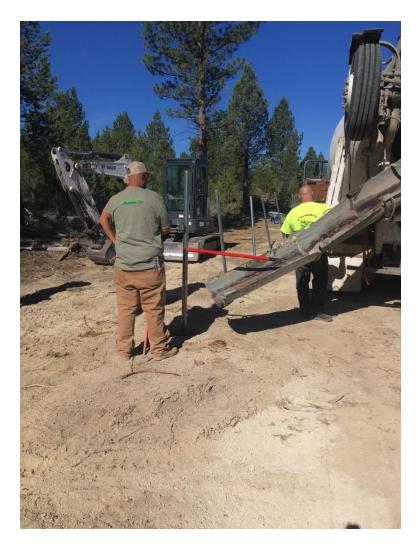
Figure 6: Image of fence posting being cemented into place.
