PROJECT INSPECTION REPORT

PROJECT NAME: Crescent Wastewater Treatment Facility

DATE AND TIME: 6/26/19 3:00 PM

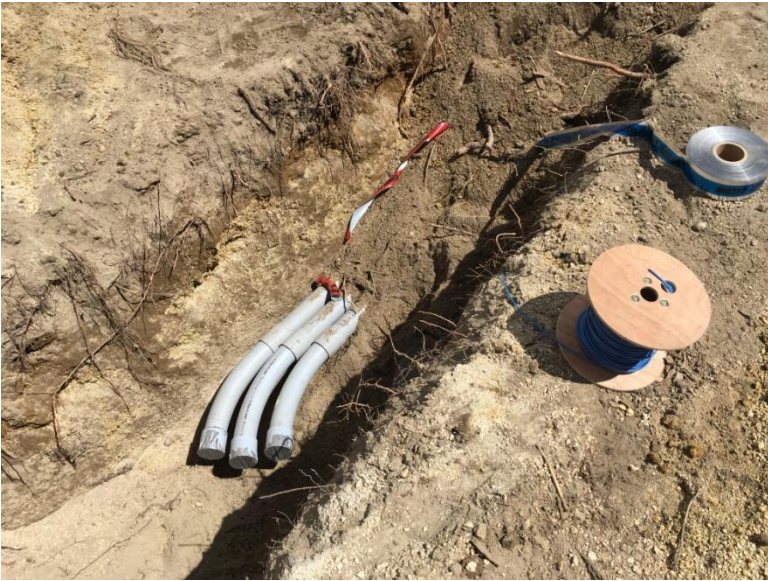
Figure 1: Trench with the electrical conduits waiting for connection. This image is on the east side of the gasline crossing.

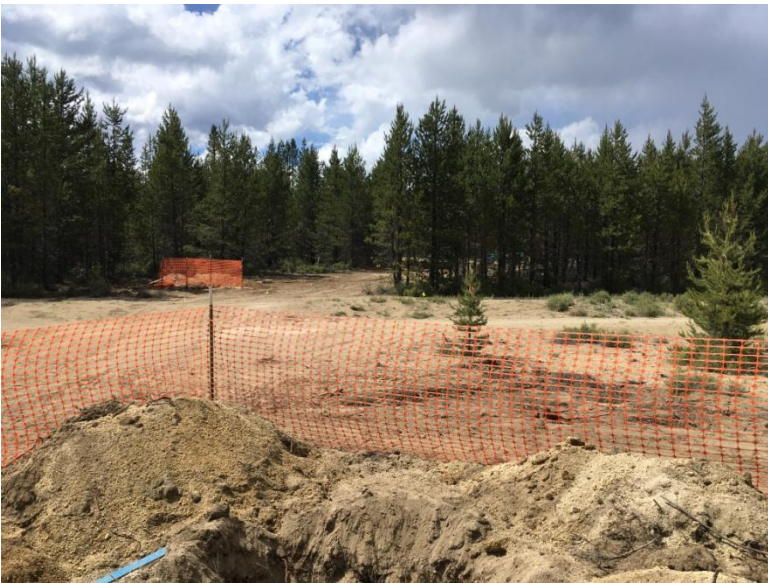
Figure 2: Looking west from the east side of the gasline crossing trench, to the mirrored trench on the west.

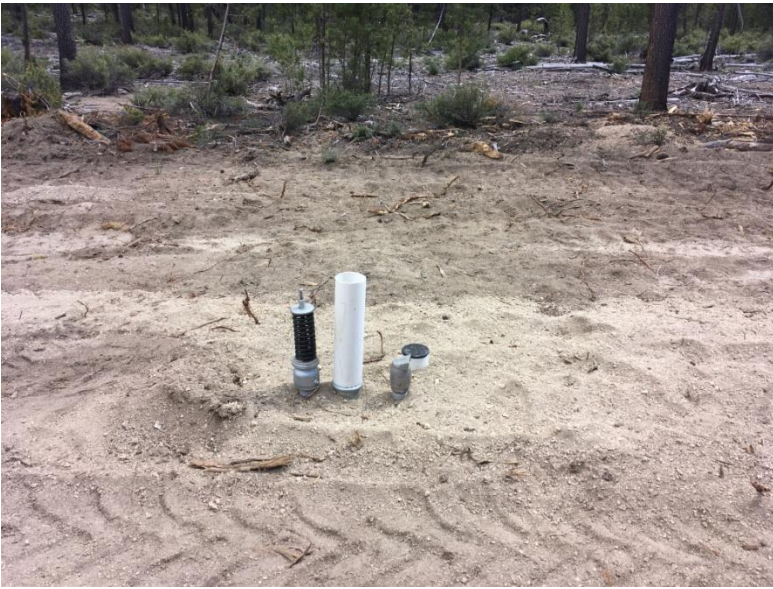
Figure 3: Looking south at the stub out of the irrigation mainline. Note the clean out.

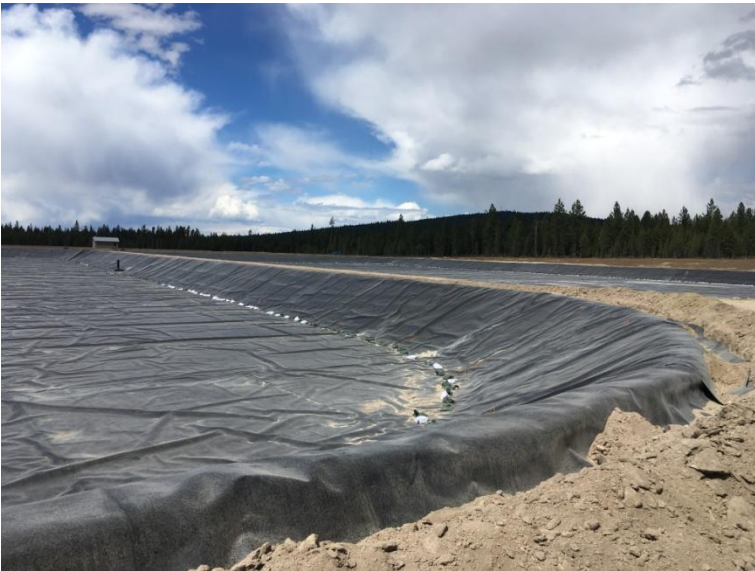
Figure 4: Looking northeast at both lagoons. Note that they are both completely lined.

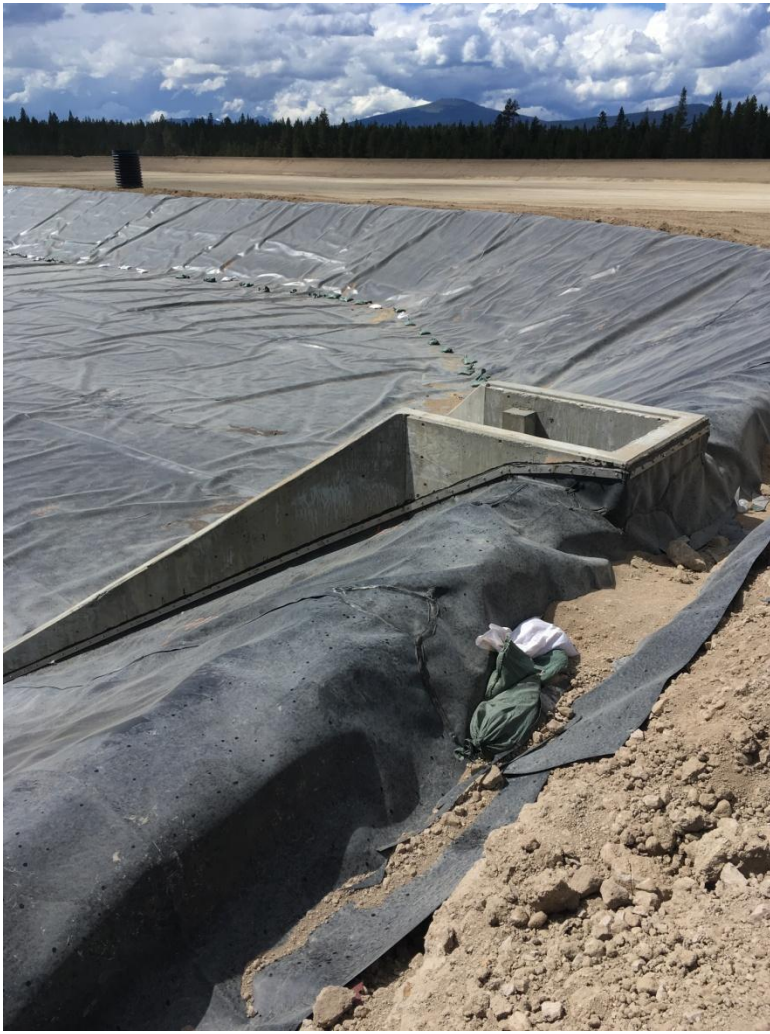
Figure 5: Looking northwest at the western lagoon that is lined. Note that the liner is bolted to the crossflow structure walls to ensure a complete seal.

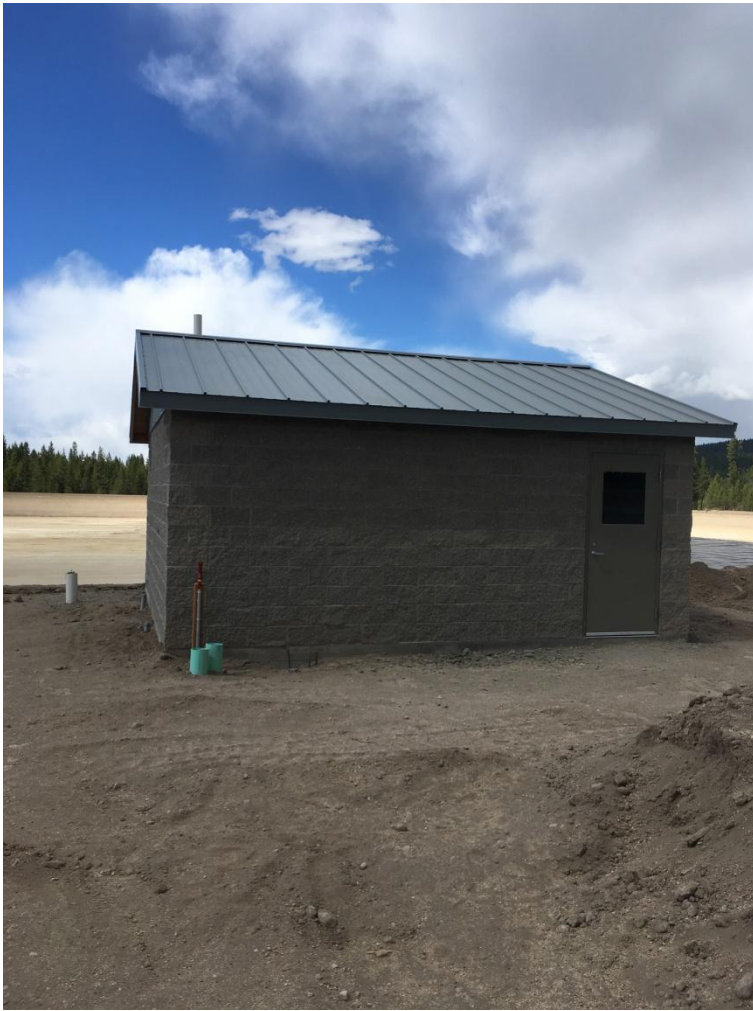
Figure 6: Looking north at the completed roof on the chlorinator building.

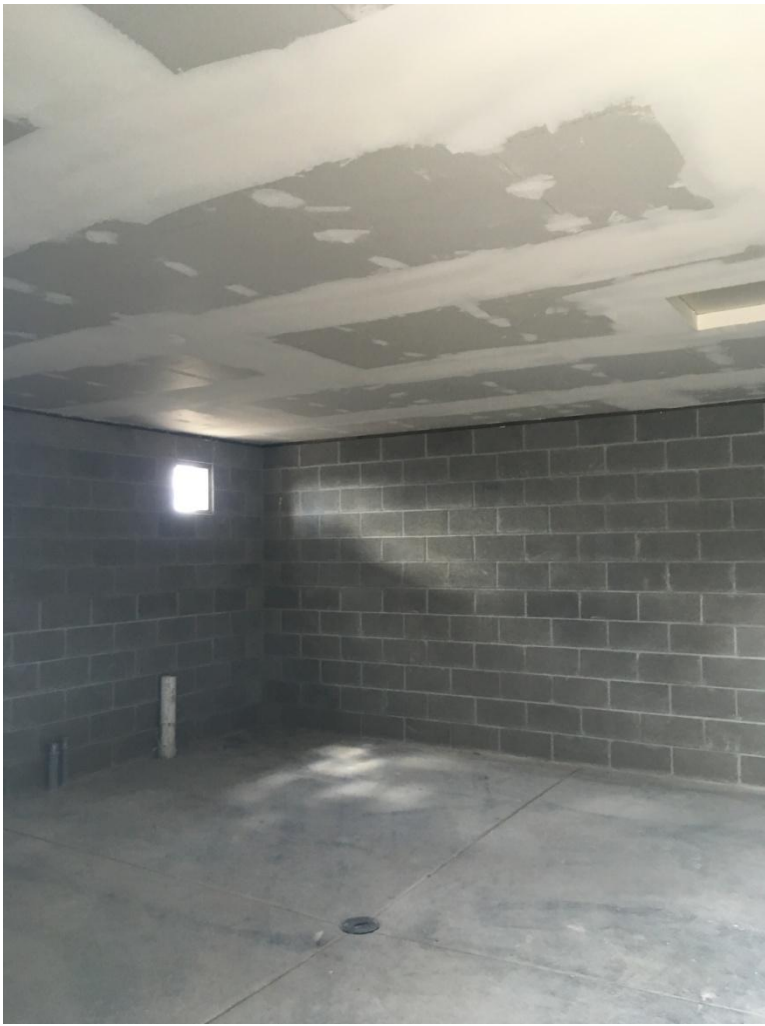
Figure 7: Looking inside the chlorinator building at the completed ceiling.

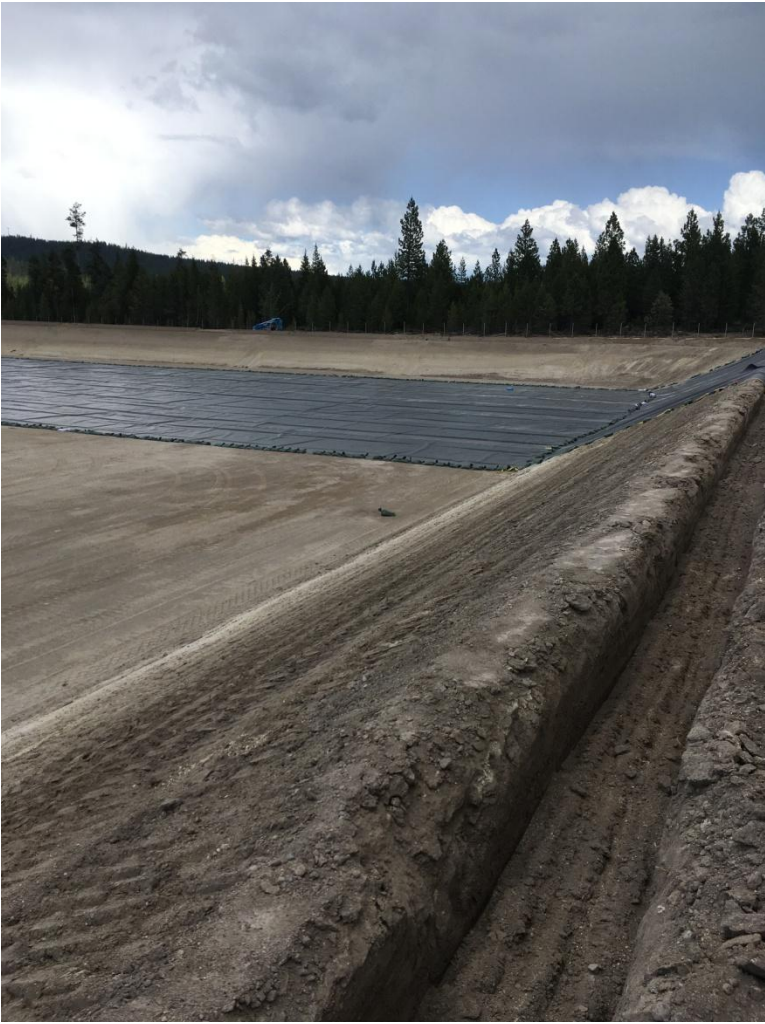
Figure 8: Looking east at the start of lining operations for the storage pond.

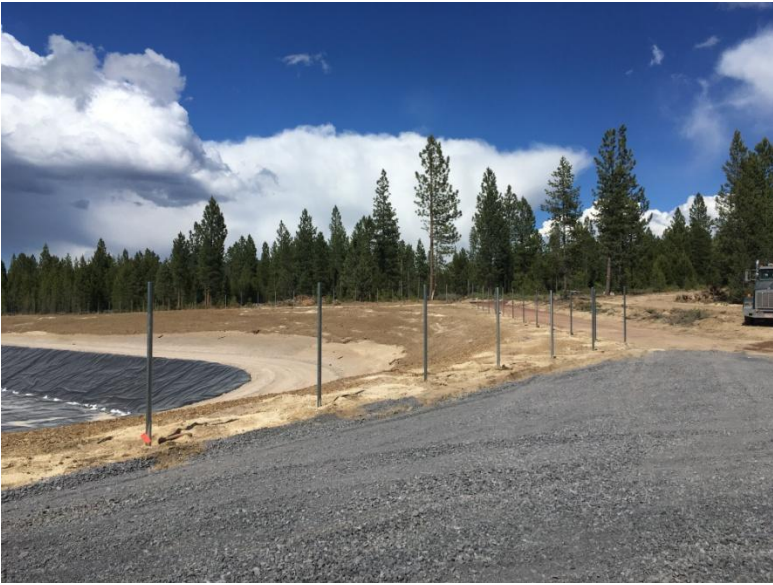
Figure 9: Looking north at the newly gravelled entrance road and fence poles running the perimeter of the facility.
