PROJECT INSPECTION REPORT

PROJECT NAME: Crescent Wastewater Treatment Facility

DATE AND TIME: 7/10/19 3:00 PM

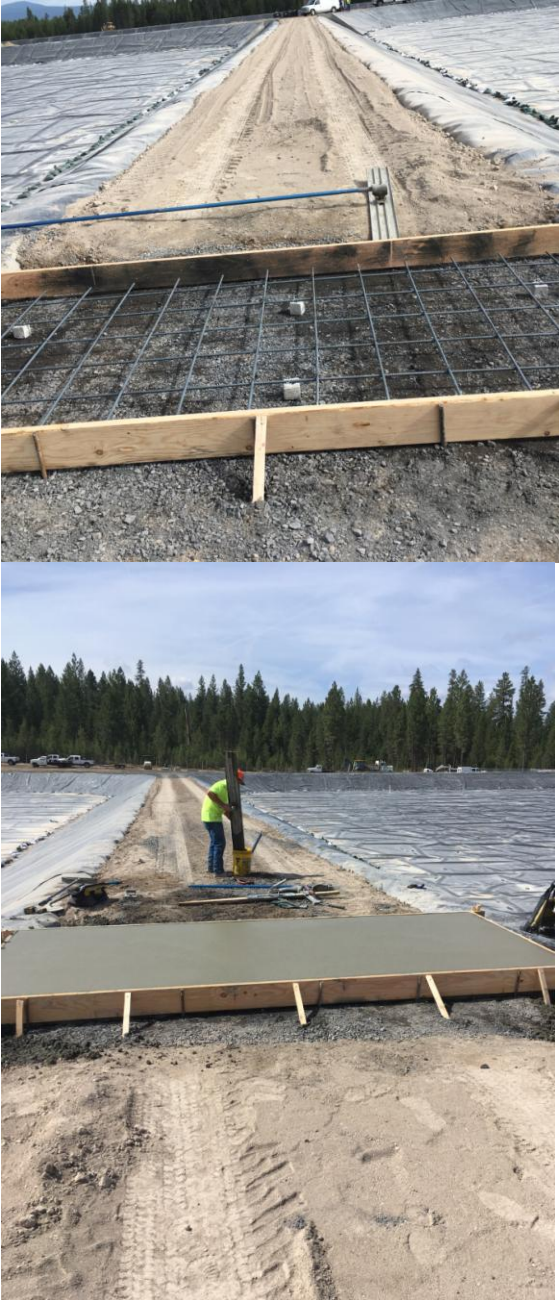
Figure 1: A before and after picture of the walkway atop the crossflow structure between the two lagoons. Note the correct spacing and placement of rebar.

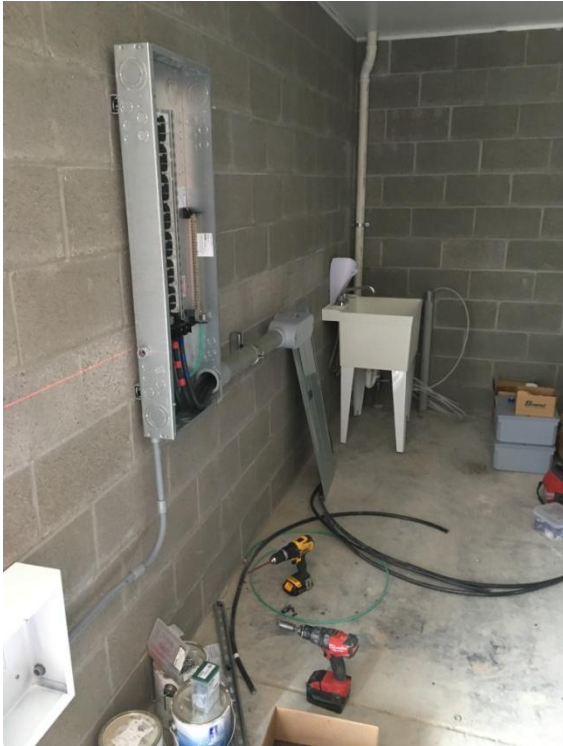
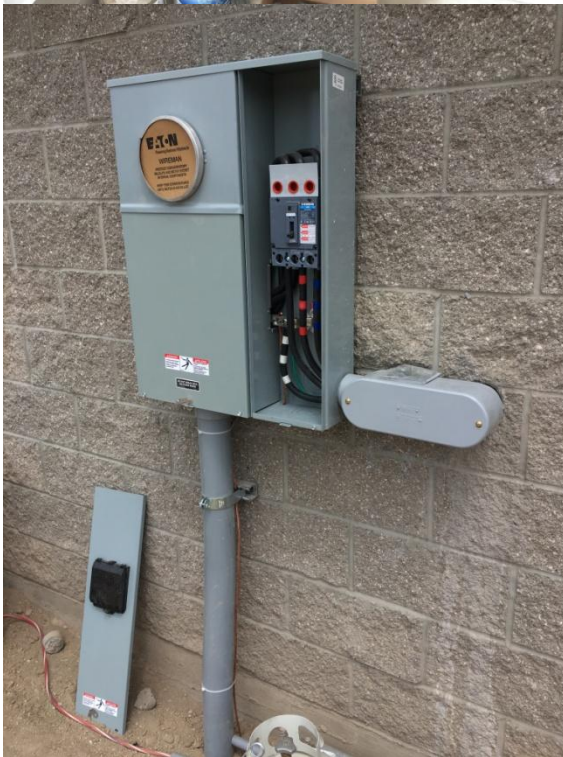
Figure 2: Looking inside and outside the chlorination building at the junction boxes ready for power hookups by mid next week.

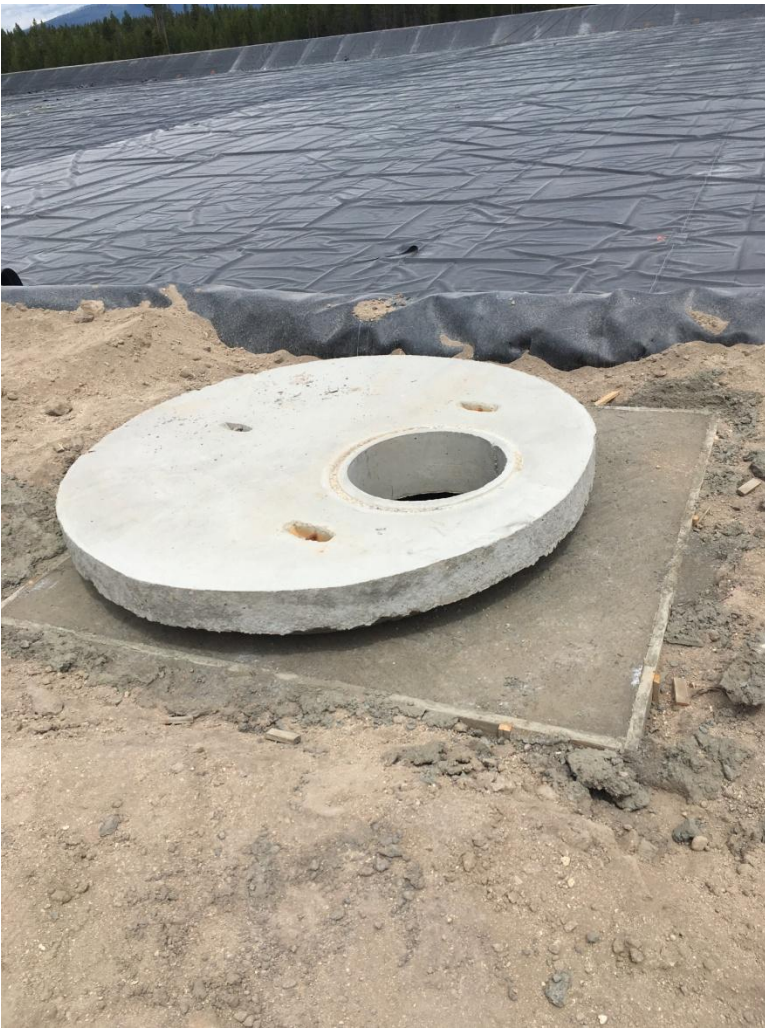
Figure 3: Riser lids have been placed with surrounding rat slab for support along the chlorinator.

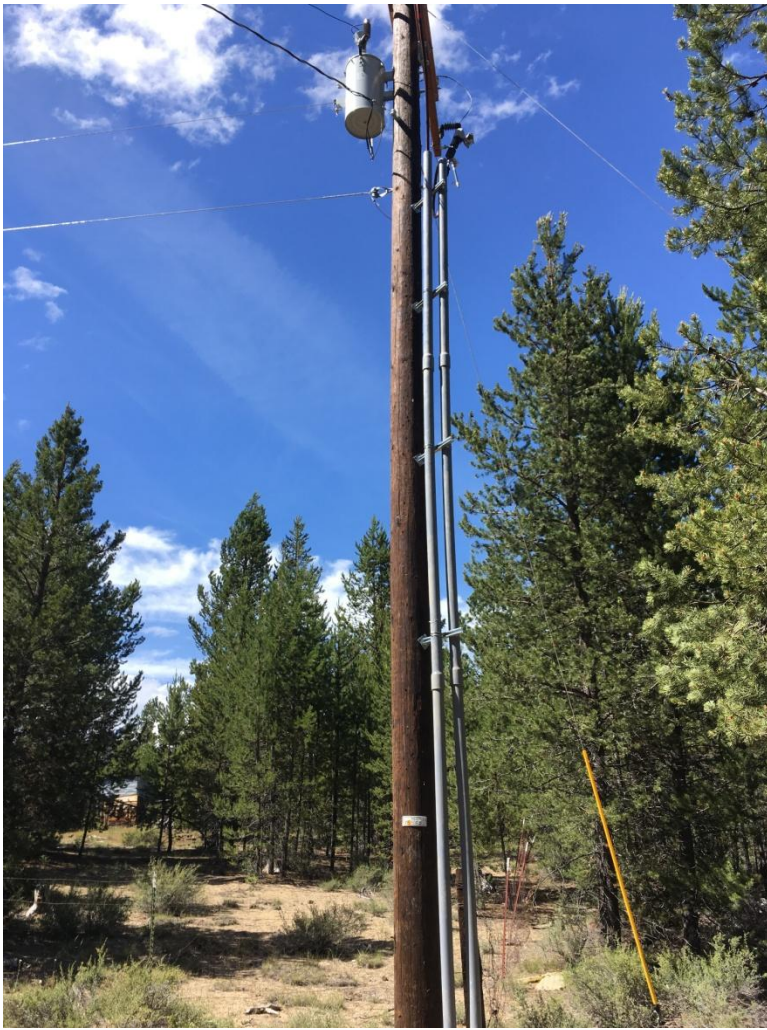
Figure 4: At the eastern edge of Pinney, 3 phase electrical runs from the poles overhead into the gray conduits which run underground to the treatment facility.

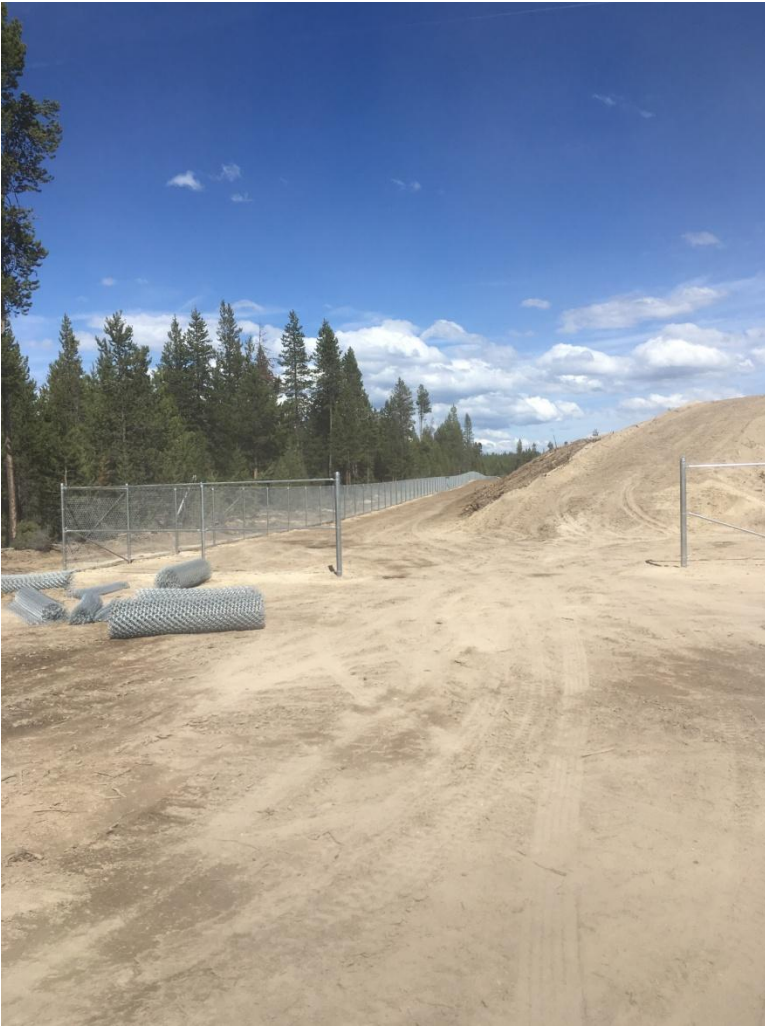
Figure 5: Looking east at the NW corner of the treatment facility. Note the cyclone fencing nearly complete along the northern facility boundary.

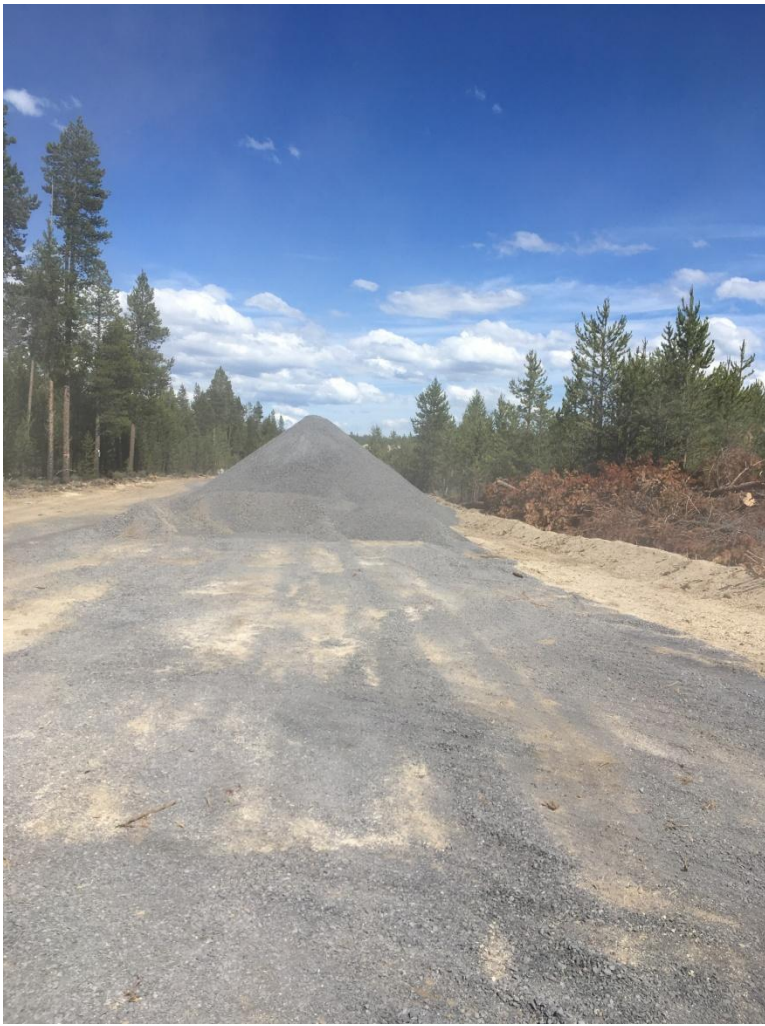
Figure 6: Looking east at the graveled access road that leads from the pipeline crossing to the NW corner of the facility. Note the gravel mound on hand that will be spread to create the remainder of the gravel roads in the facility.

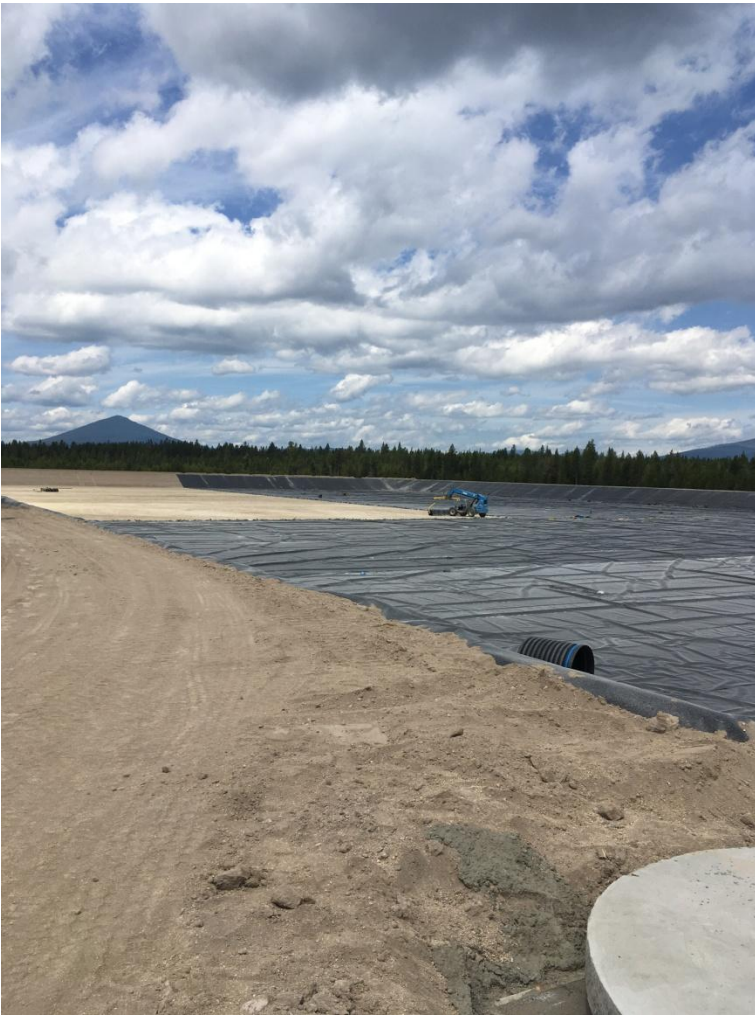
Figure 7: Looking west at liner operations in the storage pond. Only the southwest leg of the pond remains to be completed.
