PROJECT INSPECTION REPORT

PROJECT NAME: Collection System – Crescent OR Sewer System

DATE AND TIME: 3/31/20

LOCATION: Crescent, OR

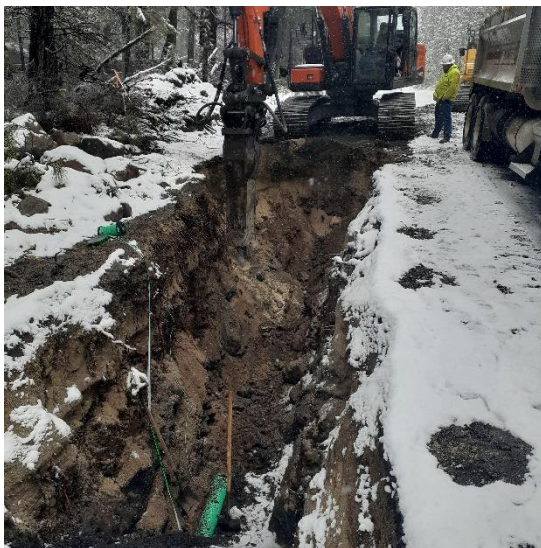
Figure 1: Image of a mainline trenchwork and jack-hammering along the north Main St crew.

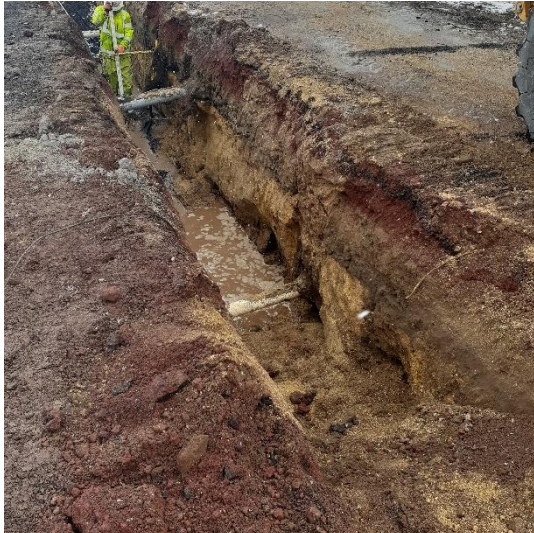
Figure 2: Image of mainline being laid on south Main St crew. Note the many utility conduits shown in the picture. Half of what is shown were unmarked.
