PROJECT INSPECTION REPORT

PROJECT NAME: Crescent Wastewater Treatment Facility

DATE AND TIME: 4/30/19 10:00 AM

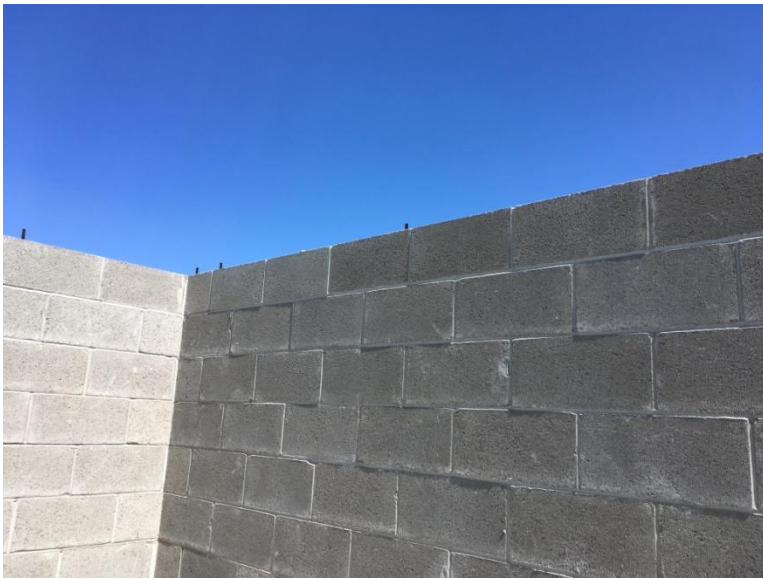
Figure 1: Looking at the top of the walls within the chlorination building. Note the threads protruding at the top of the wall, this is where the roof will attached to the building.

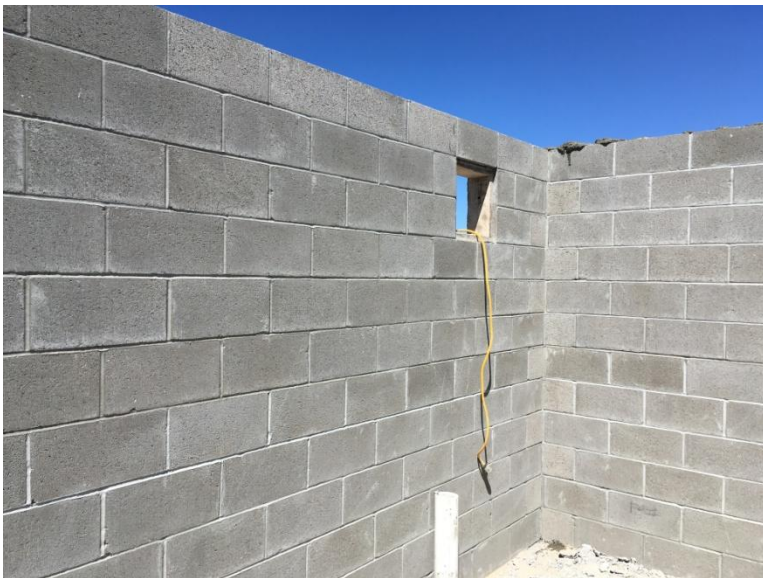
Figure 2: Looking at the northwest corner of the chlorination building. Note the window frame awaiting a window.

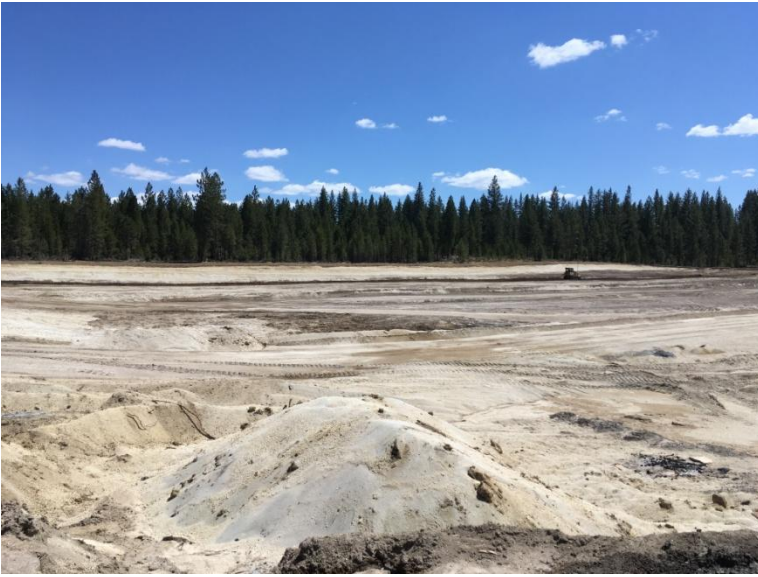
Figure 3: Looking east at large-scale discing operations. Materials are being removed from the appropriate stratigraphic layer to be mixed with pumice sands and gravels.

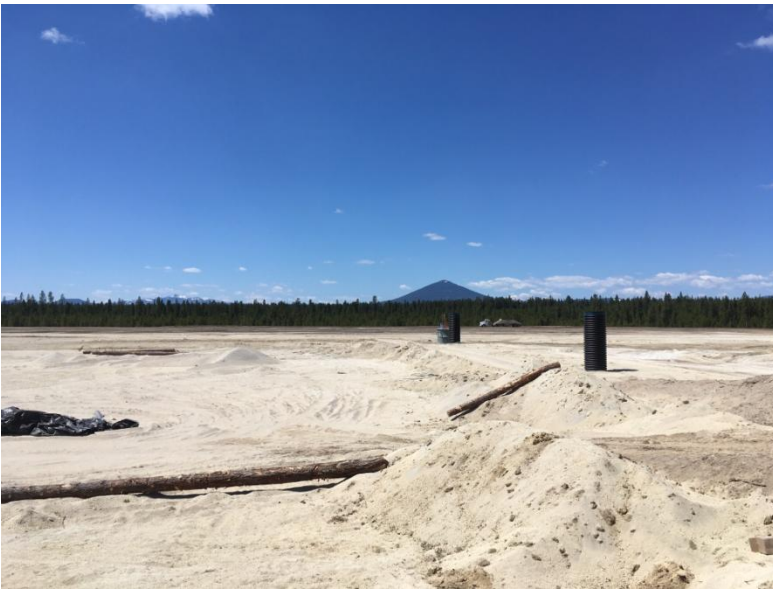
Figure 4: Looking west at large-scale discing operations occurring in the storage pond, note the belly dump in the far right-center of the picture.
