PROJECT INSPECTION REPORT

PROJECT NAME: Crescent Wastewater Treatment Facility

DATE AND TIME: 4/4/19 11:00 AM

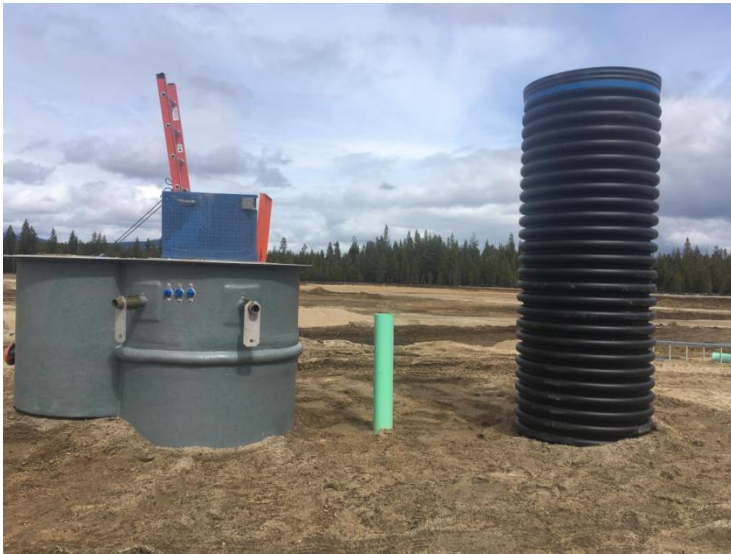
Figure 1: Looking north at the installed lift station adjacent one of the chlorinator's risers.

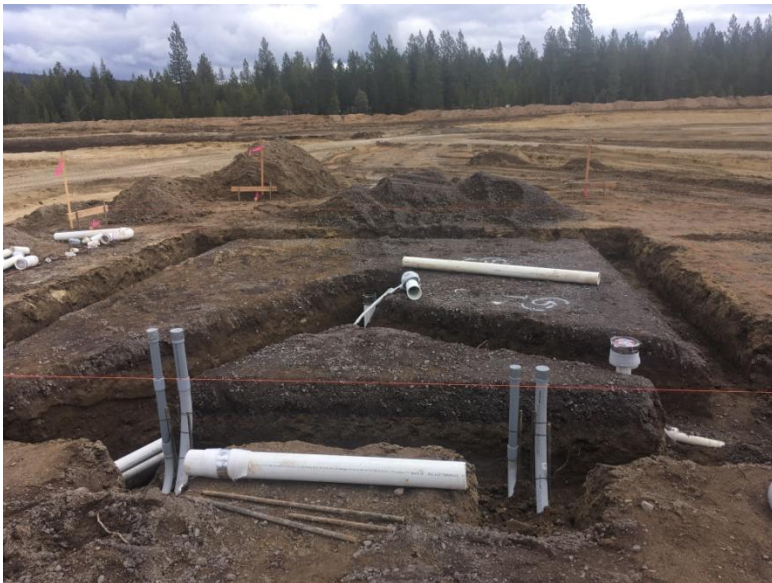
Figure 2: Looking east at the dug out foundation pad for the chlorination building with preinstalled conduits for sewage and electrical work.

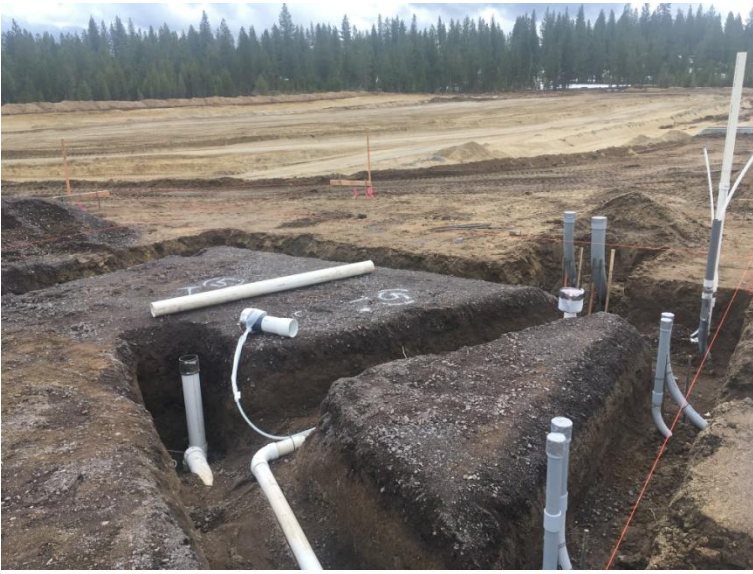
Figure 3: Looking southeast at the dug out foundation pad for the chlorination building with preinstalled conduits for sewage and electrical work.

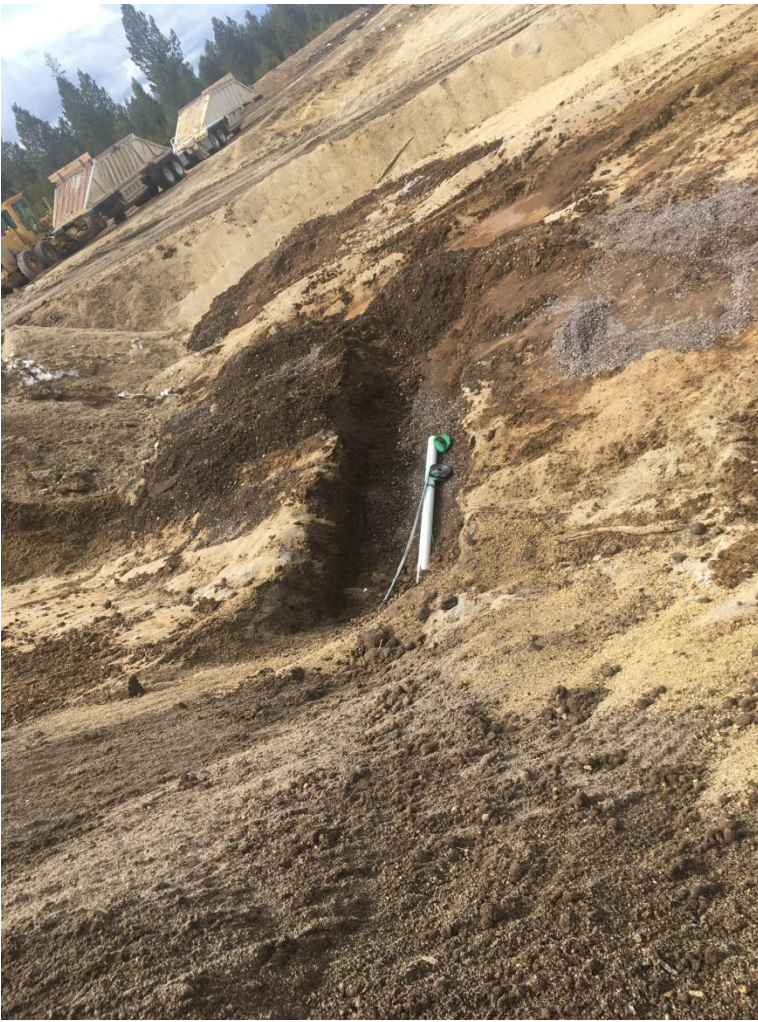
Figure 4: Looking west at the buried input pipe; this input pipe will allowed sewage to leave the collection system for retention in the facultative lagoons.

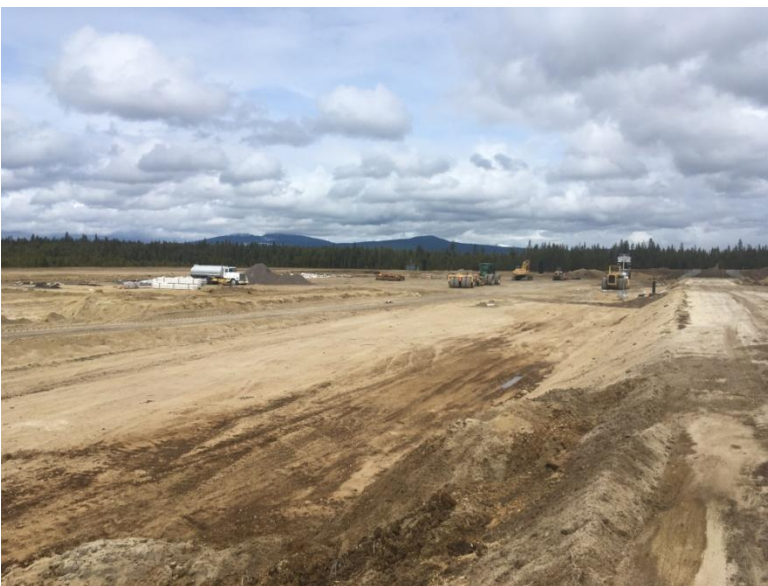
Figure 5: Looking north at the overall project. Note that in the middle of this picture, to where all the trucks are located will be the western facultative lagoon.

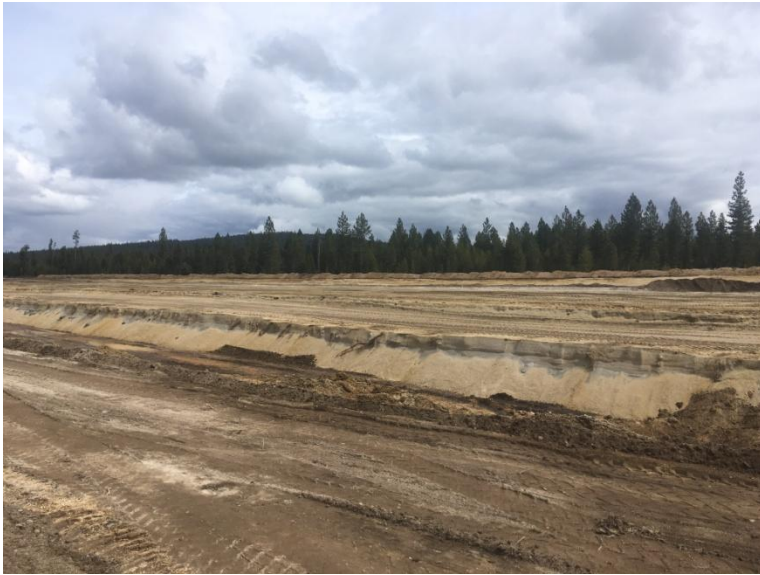
Figure 6: Looking east at the overall project. Note that this picture shows what will be the eastern facultative lagoon.
